# Service Bulletin

Bulletin No.: 22-NA-139

**Subject:** Malfunction Indicator Lamp (MIL) Illuminated and/or Driver Information Center (DIC) Displays Service Transmission Now, Unable to Shift Soon or Service Transmission, Unable to Shift Messages with DTC U1345 or U135A Set

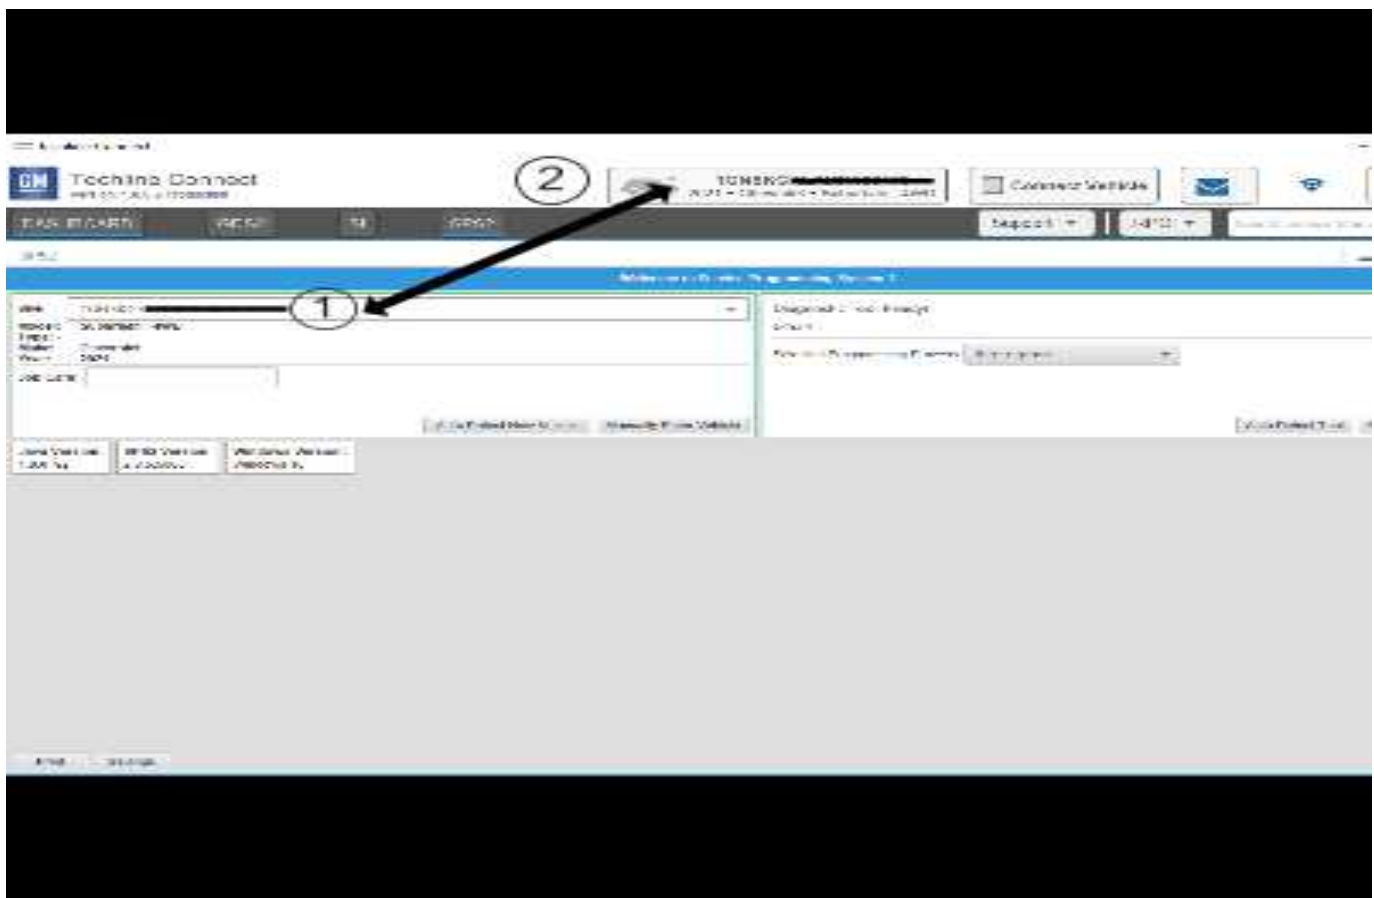
5743643

Caution: Be sure the VIN selected in the drop down menu (1) is the same as the vehicle connected (2) before beginning programming.

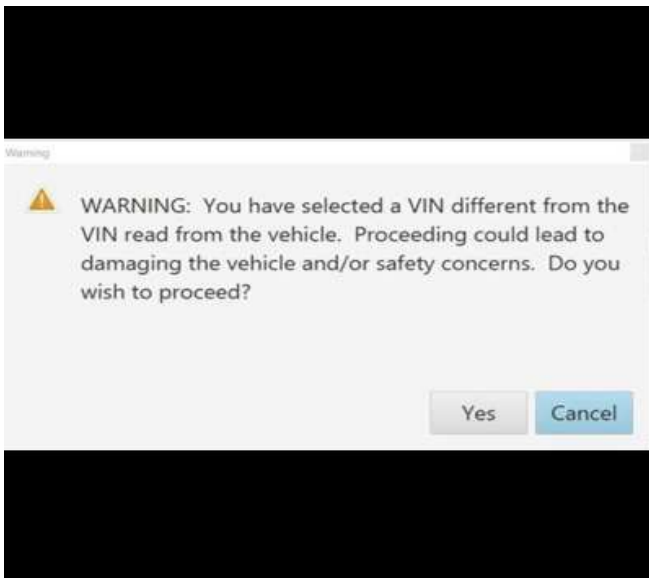
5877000

Important: If the vehicle VIN DOES NOT match, the message below will be shown.

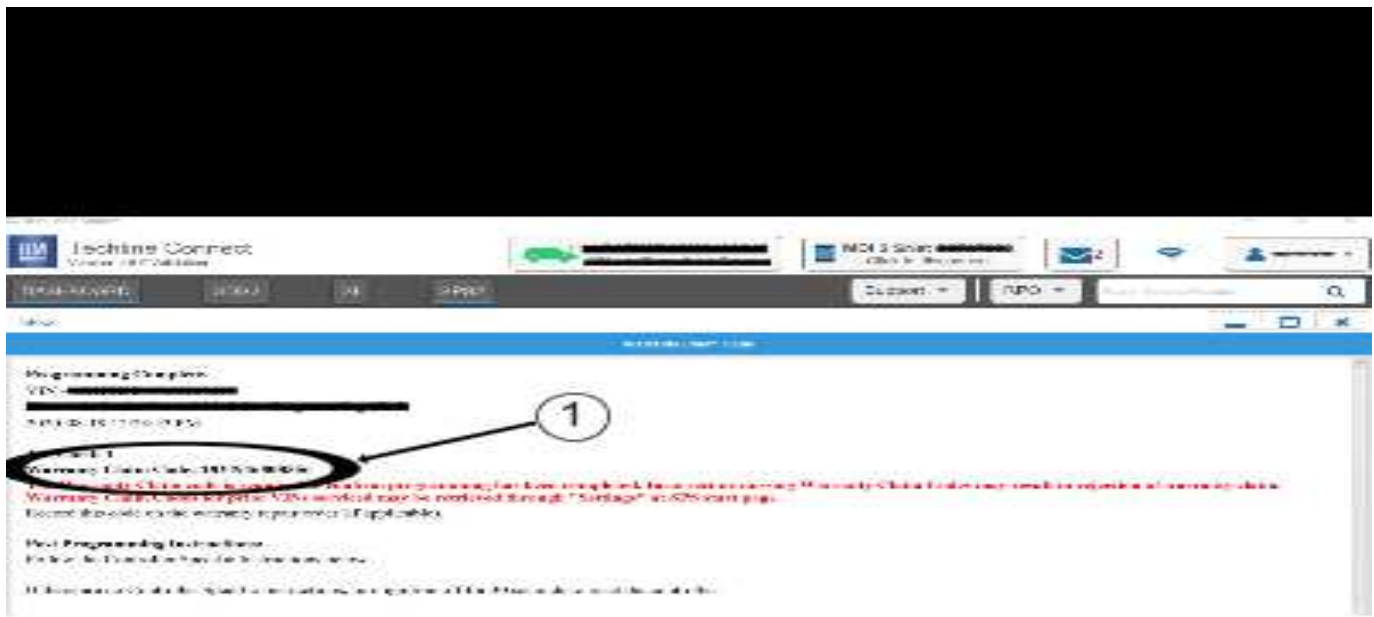
Note: The screenshot above is an example of module programming and may not be indicative of the specific module that is being programmed. Module selection and VIN information have been blacked out.

Important: To avoid warranty transaction rejections, you MUST record the warranty claim code provided on the Warranty Claim Code (WCC) screen shown above on the job card. Refer to callout 1 above for the location of the WCC on the screen.

- 2. Record the Warranty Claim Code on the job card for warranty transaction submission.
