# Service Bulletin

Bulletin No.: 22-NA-148

**Subject:** Service 4–Wheel Drive Message Illuminated in DIC with DTC C119E Set During Antilock Brake System Event

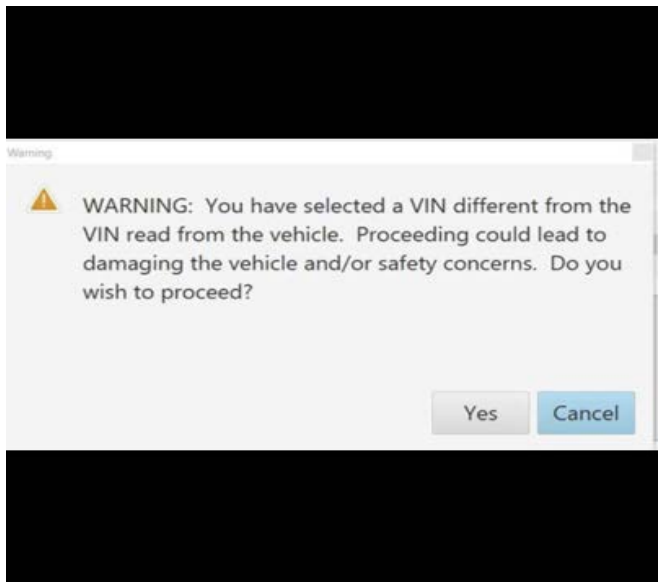
5877000

Important: If the vehicle VIN DOES NOT match, the message below will be shown

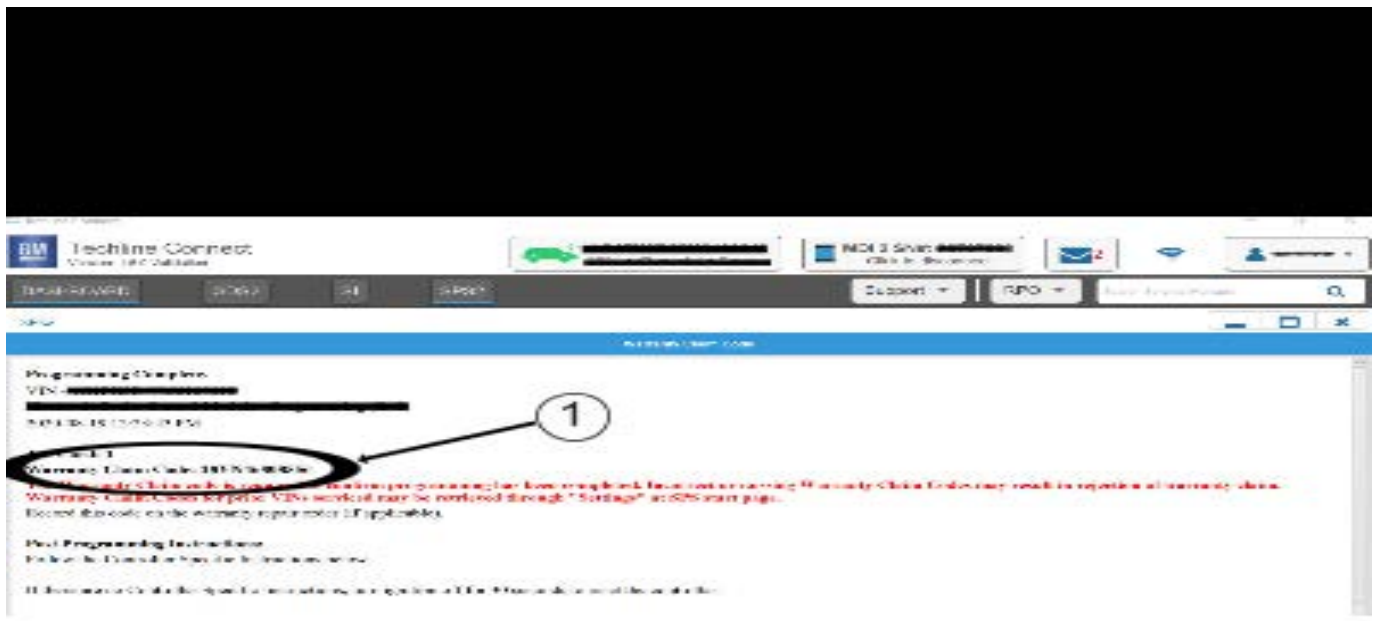
5644478

Important: To avoid warranty transaction rejections, you **MUST** record the warranty claim code provided on the Warranty Claim Code (WCC) screen shown above on the job card. Refer to callout 1 above for the location of the WCC on the screen.

2. Record Warranty Claim Code on job card for warranty transaction submission.
