## Check engine light illuminated, Fault P012800. M274 Hybrid

| Topic number | LI20.10-P-074508 |
| Function group | 20.10 - Coolant pump, coolant thermostat |
| Validity | Models 205 and 253 plug-in hybrid |

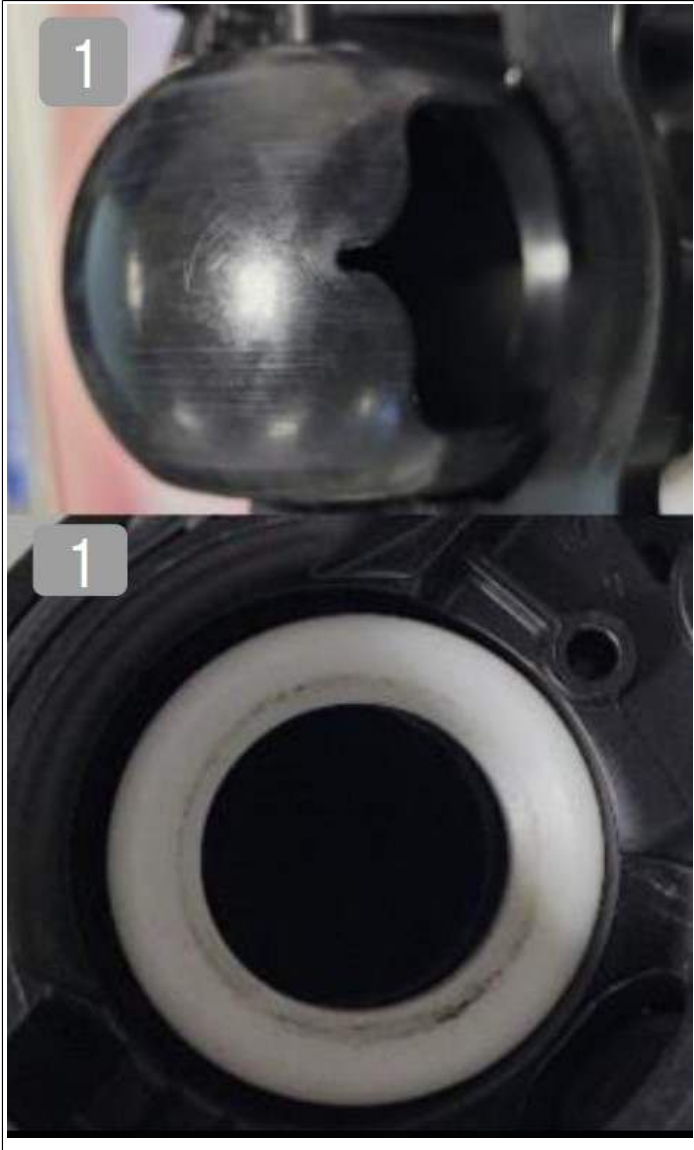
| Attachments | |
|---|---|
| <a href="#">Thermostat ball NOK.jpg</a> | |

Fault code stored P012800-The coolant temperature is below the coolant thermostat specified temperature.

- 1- Update HVAC with latest software
  - 2- Perform guided test for fault P012800 and performed repairs per XENTRY diagnosis.
- If thermostat requires replacement flush cooling circuit in both directions with 150L of water.
