### Y1A Taycan

### On Board Charger (OBC) Fault P31D200 "Charging Socket – Overtemperature"

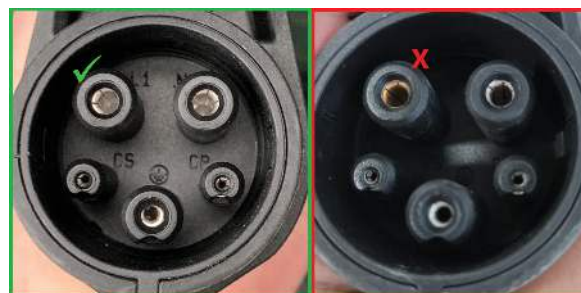
Figure 3

Visually inspect the pins in the vehicle cable connector for signs of overheating, paying particular attention to the L1 Pin. A vehicle cable and L1 Pin which was significantly or repeatedly overheated will show signs of discoloration (refer to Figure 3).

**Please advise customers to reduce charging current to maximum 30A (Mobile Charger Connect) or 50% (Mobile Charger Plus).**
