## Technical product information

| <b>Topic</b> | HVAC not working – No air flow - DTC B10AE31 High Pressure sensor - No signal DTC logged within address 08 |
| <b>Brand</b> | Bentley |
| <b>Transaction No.</b> | 2067429/2 |

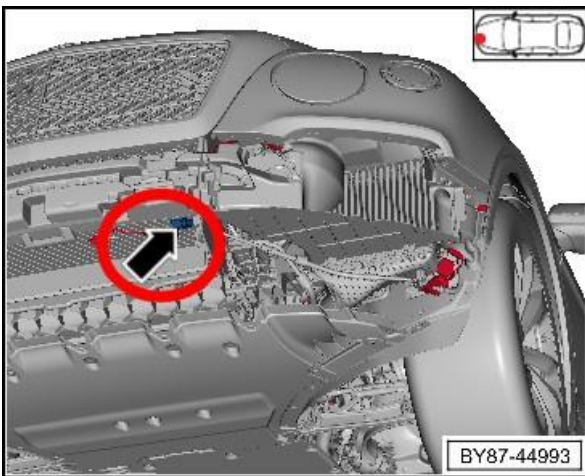
Figure 1

- HVAC not working to specification (No air flow)
- DTC B10AE31 High Pressure sensor - No signal DTC logged within address 08

- Gain access to High pressure sensor G65 (Figure 1)

- Replace G65 and associated parts (See parts information section)
  - Refit all previously removed components
  - Referring to Rep.Gr 87 - Charge the refrigeration system
- 3) Check/confirm the HVAC system is working to specification
