## Technical product information

| <b>Topic</b> | Keyless door entry does not work - Front Outside Door Handle(s) - Touch Sensor DTC B147613 present |
| <b>Brand</b> | Bentley |
| <b>Transaction No.</b> | 2062257/3 |

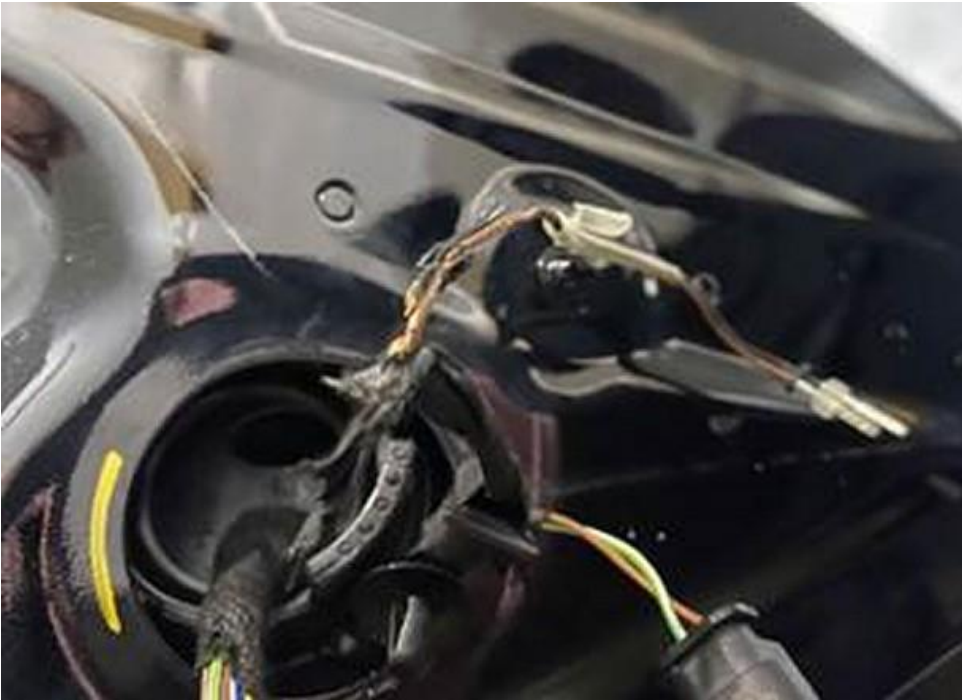
Figure 1

- Referring to Figures 1 and 2 - Perform a check of the wiring that is routed through the exterior door handle (from the convenience control module), including the wiring inside the clear heat shrink or insulating tape
- In the event that any wires show damage or signs of chaffing/breaks continue with the suggested repair as detailed in Step 3

3) Repair the broken or damaged wires as per Rep.Gr 97

TIP: Where possible, extend the length of the wires by 10mm

- Ensure the wiring does not clash with and components in particular the window mechanism
