## STAR ONLINE PUBLICATION

**Case Number:** S2108000062 REV. A

**Symptom/Vehicle Issue:** Rumbling, Rough Engine Vibration 1600 to 1800, CEL (Check Engine Lamp) On, Cylinder Misfire DTC's

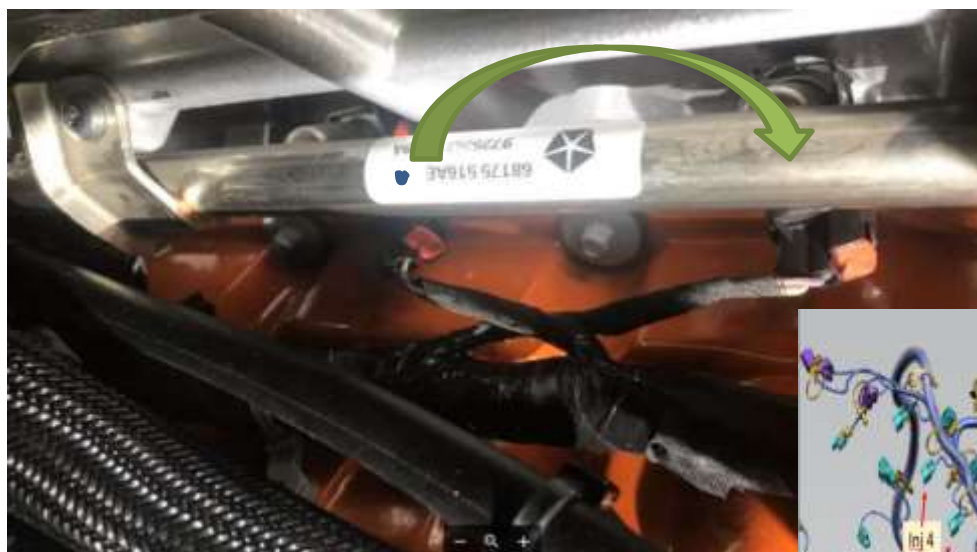
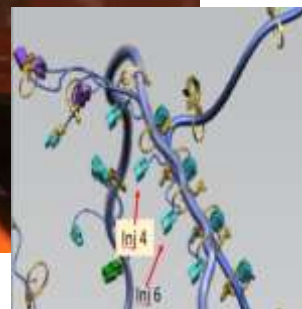
6.2L – DT Ram

**Repair Procedure:** The below example is consistent with the DTC's in this case, where the number 4 and 6 harness connections were improperly connected, (crossed) to the wrong injector position. Different DTC's will set if other injectors are involved. This condition may not set immediately but require some driving and PCM fuel adaptive changing to trigger the DTC.
