**NUMBER:** 14-008-21

3.0L Diesel Crankshaft Tone Wheel Loss of Signal - X95 Warranty Extension

This bulletin involves replacing the crankshaft tone wheel.

Jeep Grand Cherokee

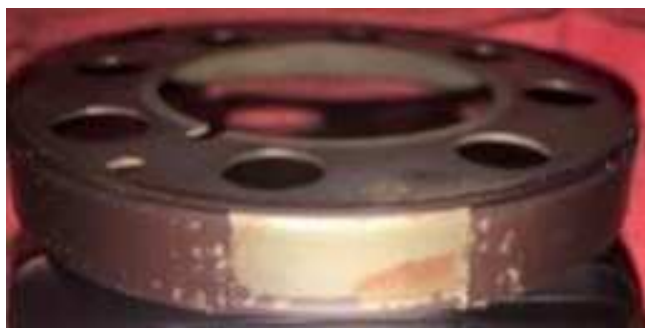
**Fig. 1**

**NOTE:** This symptom/condition is cause from missing magnetic material on the crankshaft tone wheel (Fig. 1) .

**Missing Magnetic Material On Tone Wheel**
