**NUMBER:** 14-007-21

3.0L Diesel Crankshaft Tone Wheel Loss of Signal - X94 Warranty Extension

This bulletin involves replacing the crankshaft tone wheel.

RAM 1500 Pickup

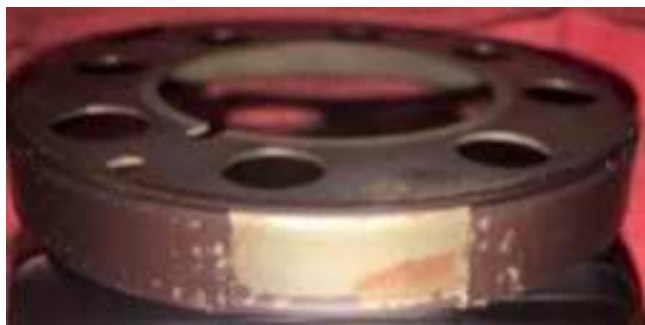
**NOTE:** This symptom/condition is caused from missing magnetic material on the crankshaft tone wheel ([Fig. 1](#)) .

**Fig. 1**  
**Missing Magnetic Material On Tone Wheel**
