## TECHNICAL SERVICE BULLETIN

### 2020-2022 F-Super Duty - Illuminated ABS Indicator, Engine Will Not Turn Off And/Or Various Electrical Symptoms

**22-2313**

04 August  
2022

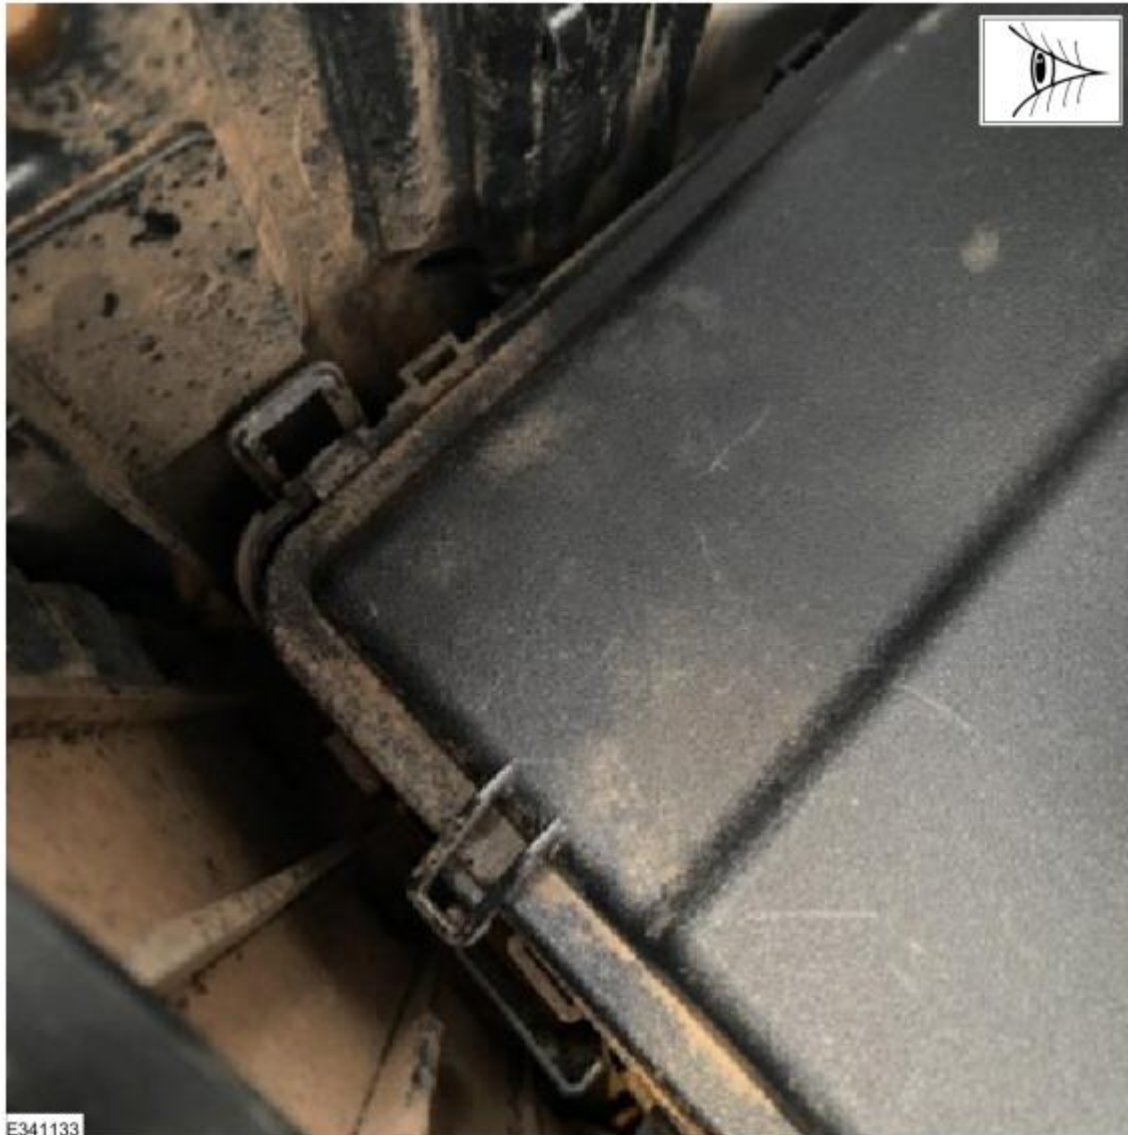
1. Visually inspect the BJB for signs of water/moisture intrusion. Are there signs of water/moisture intrusion into the BJB and/or broken cover tabs/locking fingers?

Figure 1 - Example of moisture intrusion with BJB cover on

## 2. Replace the BJB assembly.

- (1). Remove the battery and battery tray. Refer to the Workshop Manual, Section 414-01.
- (2). Remove the BJB cover.
- (3). Loosen the two BJB connector bolts and remove the battery power cable nut. Disconnect the battery power cable from the BJB.

- (4). Release the BJB from the two locking tabs on each side of the BJB.
- (5). Lift the BJB to allow access to both BJB connectors. Disconnect both connectors and remove the BJB.

- (6). Remove the cover from the new BJB and connect both connectors to the new BJB.
- (7). Install the new BJB into both locking tabs.
- (8). Attach the battery power cable and tighten the battery power cable nut to 10.5 Nm (93 lb-in). Tighten the connector bolts to 5.4 Nm (48 lb-in).

- (9). Install the new BJB cover making sure the cover tabs/locking fingers are installed correctly.
- (10). Install the battery tray and battery back into the vehicle. Refer to WSM, Section 414-01.

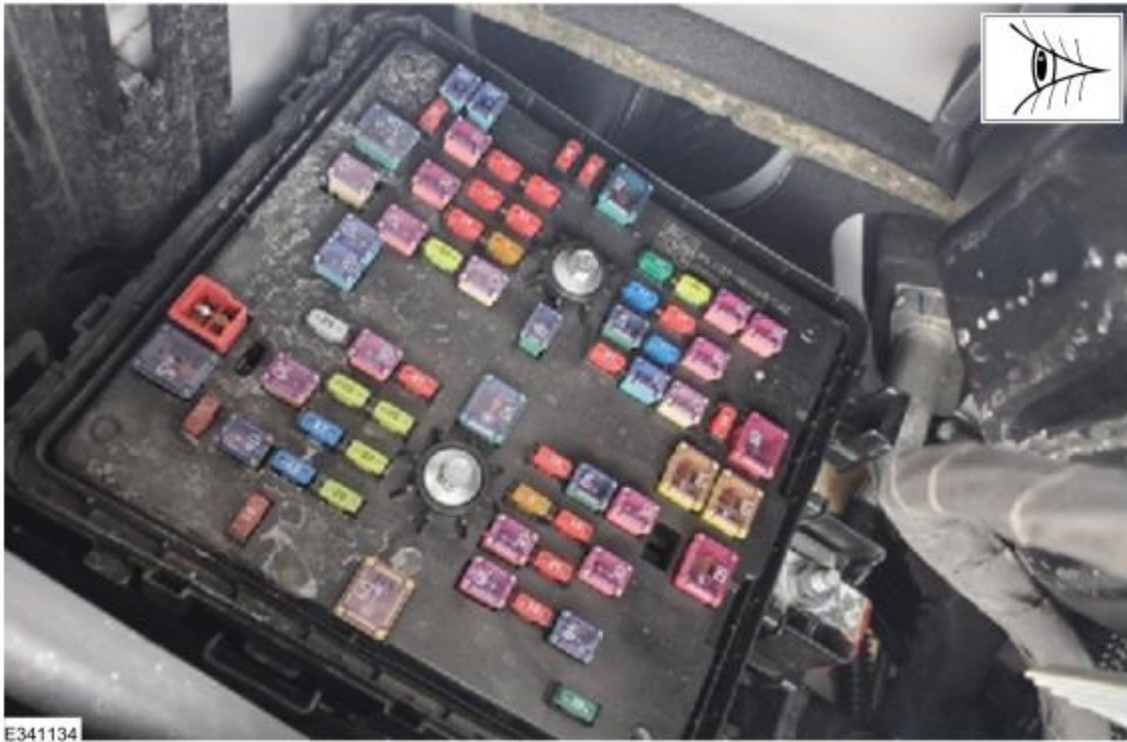
Figure 2 - Example of moisture intrusion with BJB cover off

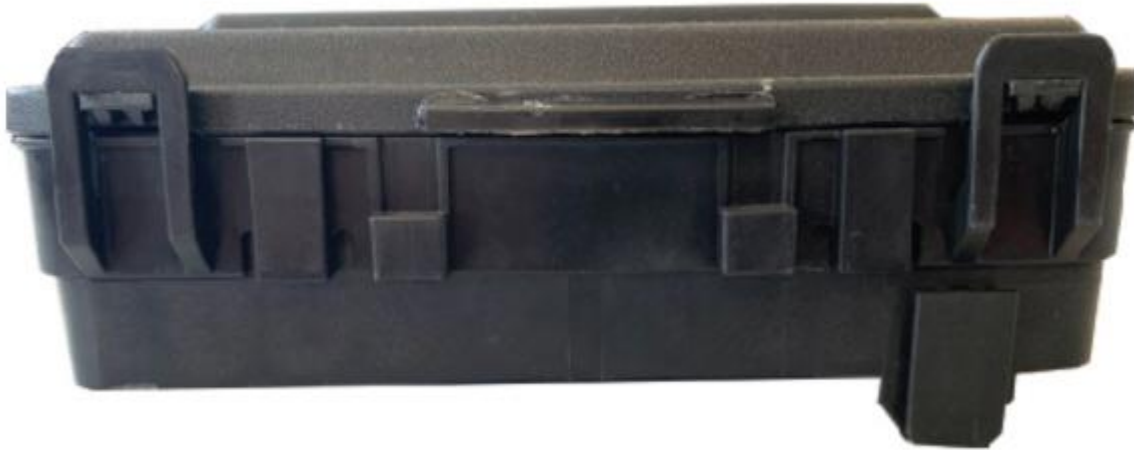
E341135

Figure 3 - Correct cover installation

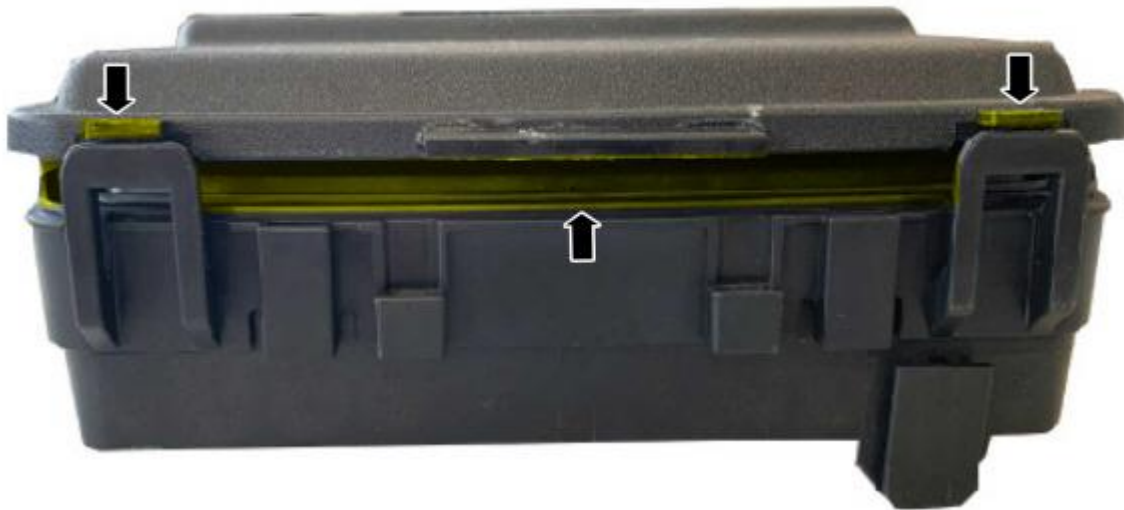
E341136

Figure 4 - Incorrect cover installation

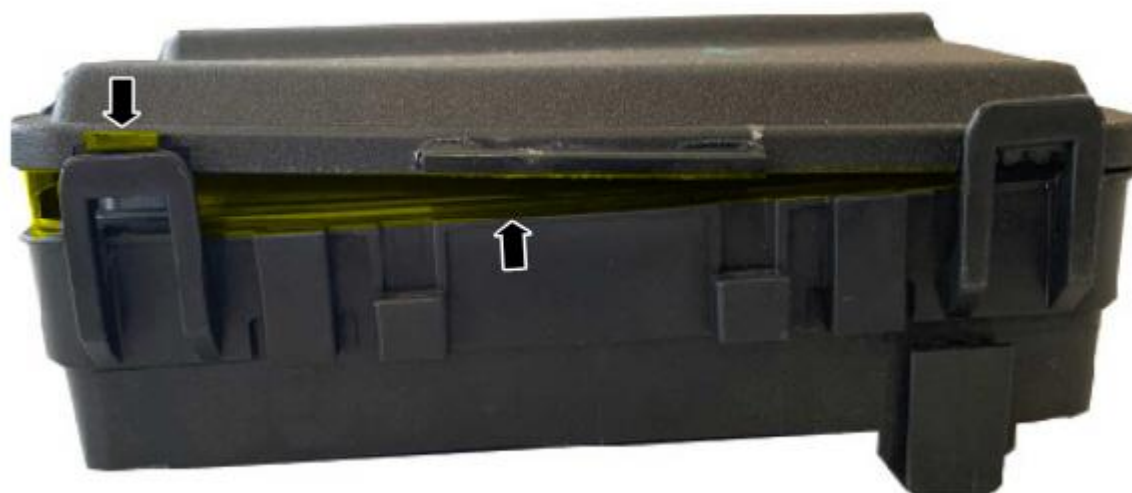
E341137

Figure 5 - Incorrect cover installation

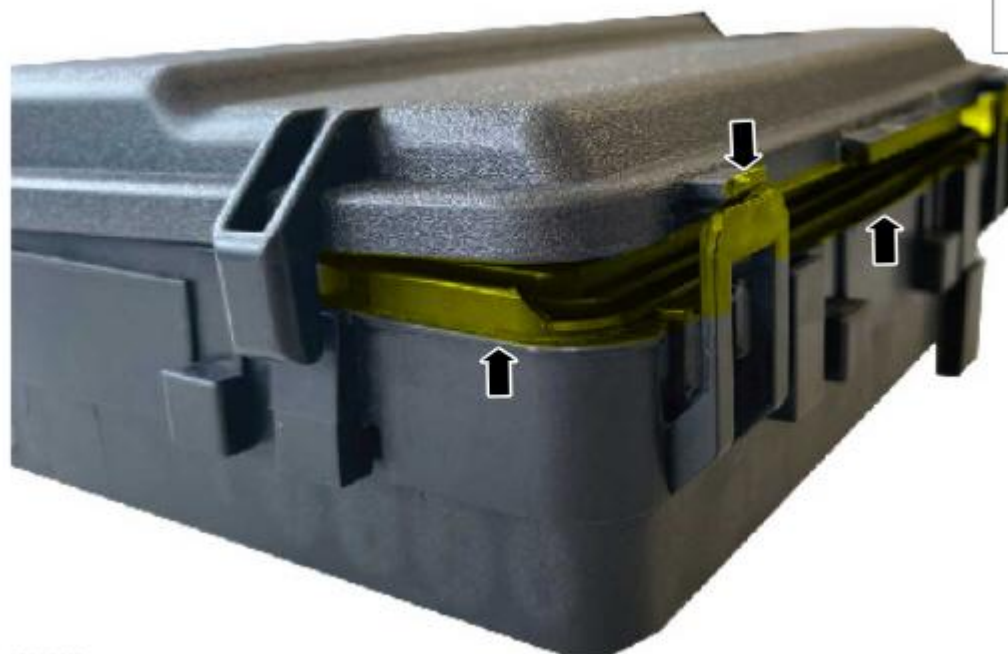
E341138

Figure 6 - Incorrect cover installation
