## TECHNICAL SERVICE BULLETIN

### 400 Watt DC/AC Inverter System Inoperative With B1330:9A In The BCM

22-2324

Ford  
2021-2022 F-150

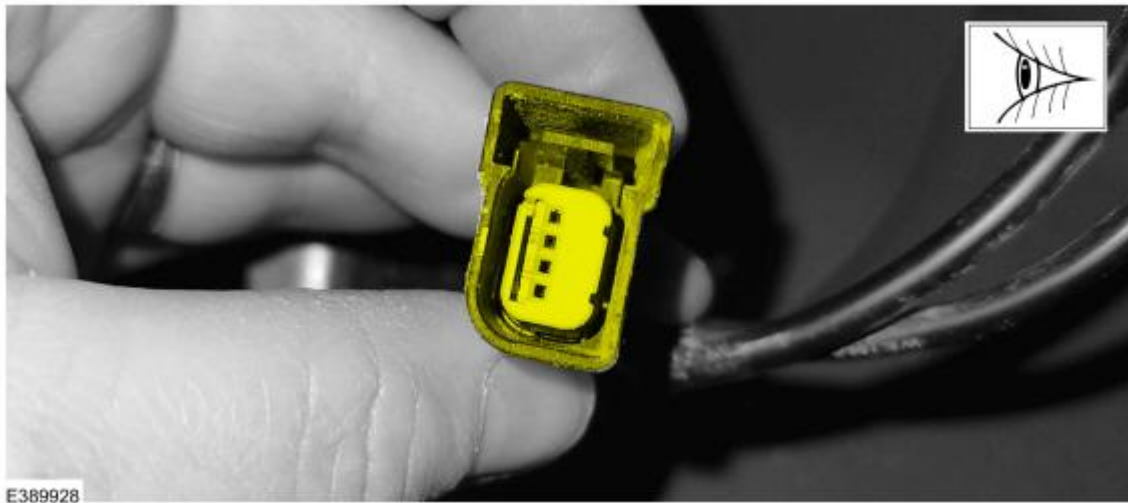
Figure 2

2. Using a suitable tool, carefully cut and remove the pickup bed AC power outlet socket harness retainer from the pickup bed AC power outlet socket harness. Discard the retainer.
3. Inspect connector C4628 for the presence of corrosion, dirt and/or damage. Is corrosion, dirt and/or damage present in connector C4628? (Figure 2)

(1). Yes - replace the pickup bed AC power outlet socket assembly. Refer to Workshop Manual (WSM), Section 414-05. Replace the body side harness assembly (13A409) of connector C4628. Proceed to Step 4.

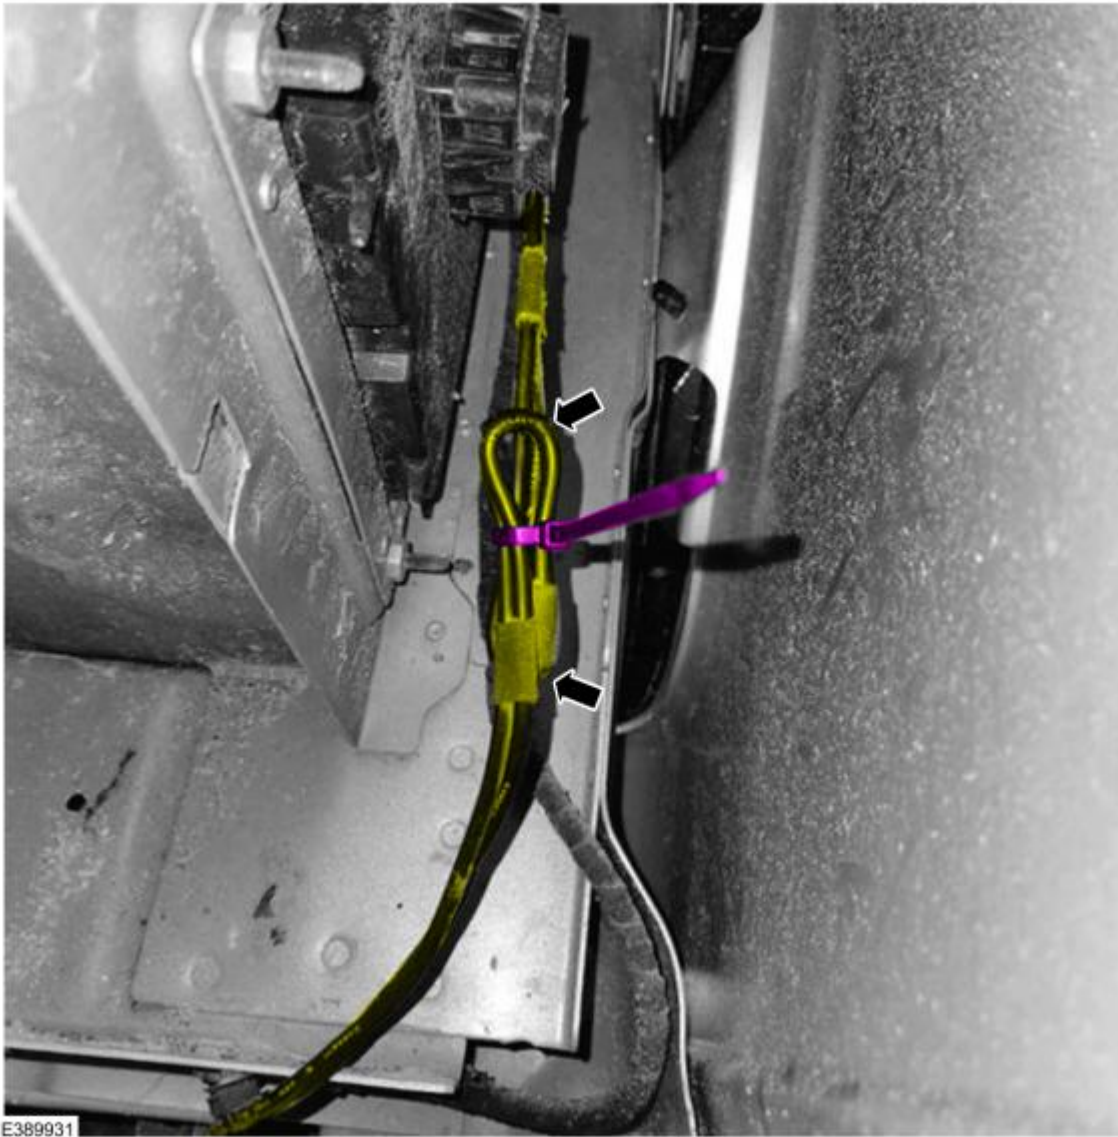
Figure 5

**CAUTION: The bend radius of the pickup bed AC power outlet socket harness should be no less than 4 mm. Hard kinks and tight bends of the pickup bed AC power outlet socket harness can lead to wire damage.**

6. Fold approximately 7 in. (185 mm) of the remaining/loose pickup bed AC power outlet socket harness in 2 bends just behind the pickup bed AC power outlet socket panel. Secure the folded wire with a wire tie. Inspect the routing of the harness to make sure it is not pulled too tight against the body sheet metal near the harness retainer and provides just enough length. (Figure 5)
