# VOLUNTARY SERVICE CAMPAIGN

| AT22-006 | NTB22-057 | July 14, 2022 |

## VOLUNTARY EMISSION SERVICE CAMPAIGN 2021 ROGUE; ENGINE CONTROL MODULE, TRANSMISSION CONTROL MODULE, AND SHIFT CONTROL MODULE REPROGRAM

**CAMPAIGN ID #:** P2A07  
**APPLIED VEHICLES:** 2021 Rogue (T33)

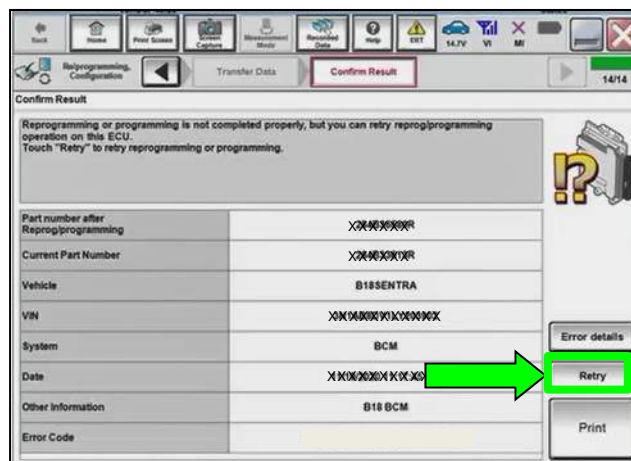
Figure 16

If reprogramming does not complete and the “!?” symbol displays as shown in Figure 16:

- Check battery voltage (12.0 – 15.5V).
- Ignition is ON, Engine is OFF.
- External Bluetooth® devices are OFF.
- All electrical loads are OFF.
- Select **Retry** and follow the on screen instructions.

**NOTE:** **Retry** may not go through on first attempt and can be selected more than once.

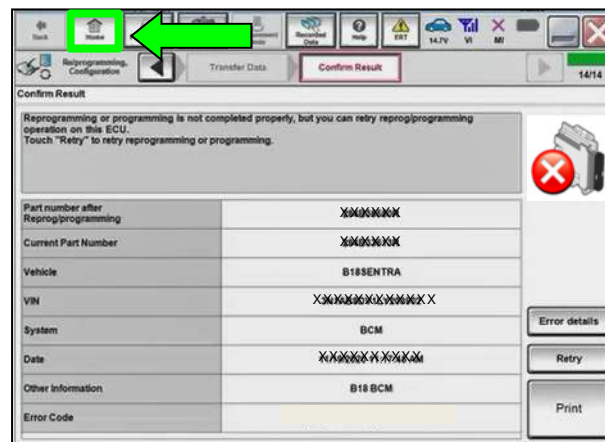
Figure 17

If reprogramming does not complete and the “X” symbol displays as shown in Figure 17:

- Do not disconnect the VI or shut down C-III plus if reprogramming does not complete.
- Check battery voltage (12.0 – 15.5V).
- CONSULT A/C adapter is plugged in.
- Ignition is ON, Engine is OFF.
- Transmission in Park.
- All C-III plus / VI cables are securely connected.
- All C-III plus updates are installed.
- Select **Home**, and then restart the reprogram procedure from the beginning.
