# TECHNICAL SERVICE BULLETIN

| EC22-007 | NTB22-066 | July 29, 2022 |

## DTC P2DFD STORED IN THE ECM

**APPLIED VEHICLES:** 2022 Rogue (T33)

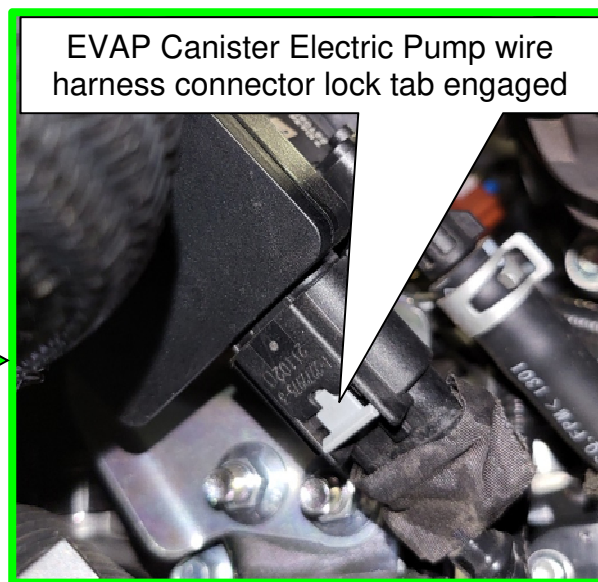
Figure 2

If you confirm DTC P2DFD (PURGE PUMP PERFORMANCE) is stored in the ECM,

1. Turn the ignition OFF.
2. Disconnect the EVAP Canister Electric Pump wire harness connector (Figure 2).
3. Re-connect the EVAP Canister Electric Pump wire harness connector and then verify the wire harness connector is fully seated, connected, and the wire harness connector lock tab is engaged (Figure 2).
