# Technical Service Bulletin

LIFTGATE SWITCH DOES NOT WORK

Bulletin No.: 09-004/22

Last Issued : 08/08/2022

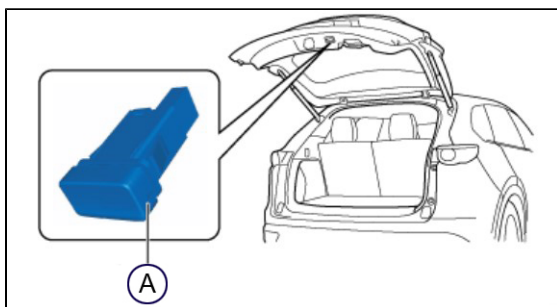
Some CX-5 and CX-30 customers may find that the liftgate does not close when pressing the power liftgate (PLG) rear switch (A) located on the interior liftgate trim. This may be caused by PLG switch corrosion. Water from a high pressure car washer and/or condensation may drip onto the switch connector and cause corrosion.

**NOTE:** CX-5 shown below

To eliminate this concern, the PLG rear switch has been modified with a waterproof connector.
