# Service Bulletin

Bulletin No.: 22-NA-163

Subject: Service Power Steering Message with DTC U3000 Set

| Brand: | Model: | Model Year: | | VIN: | | Engine: | Transmission: |
|---|---|---|---|---|---|---|---|
| Buick | Envision | 2022 | 2022 | | | | |

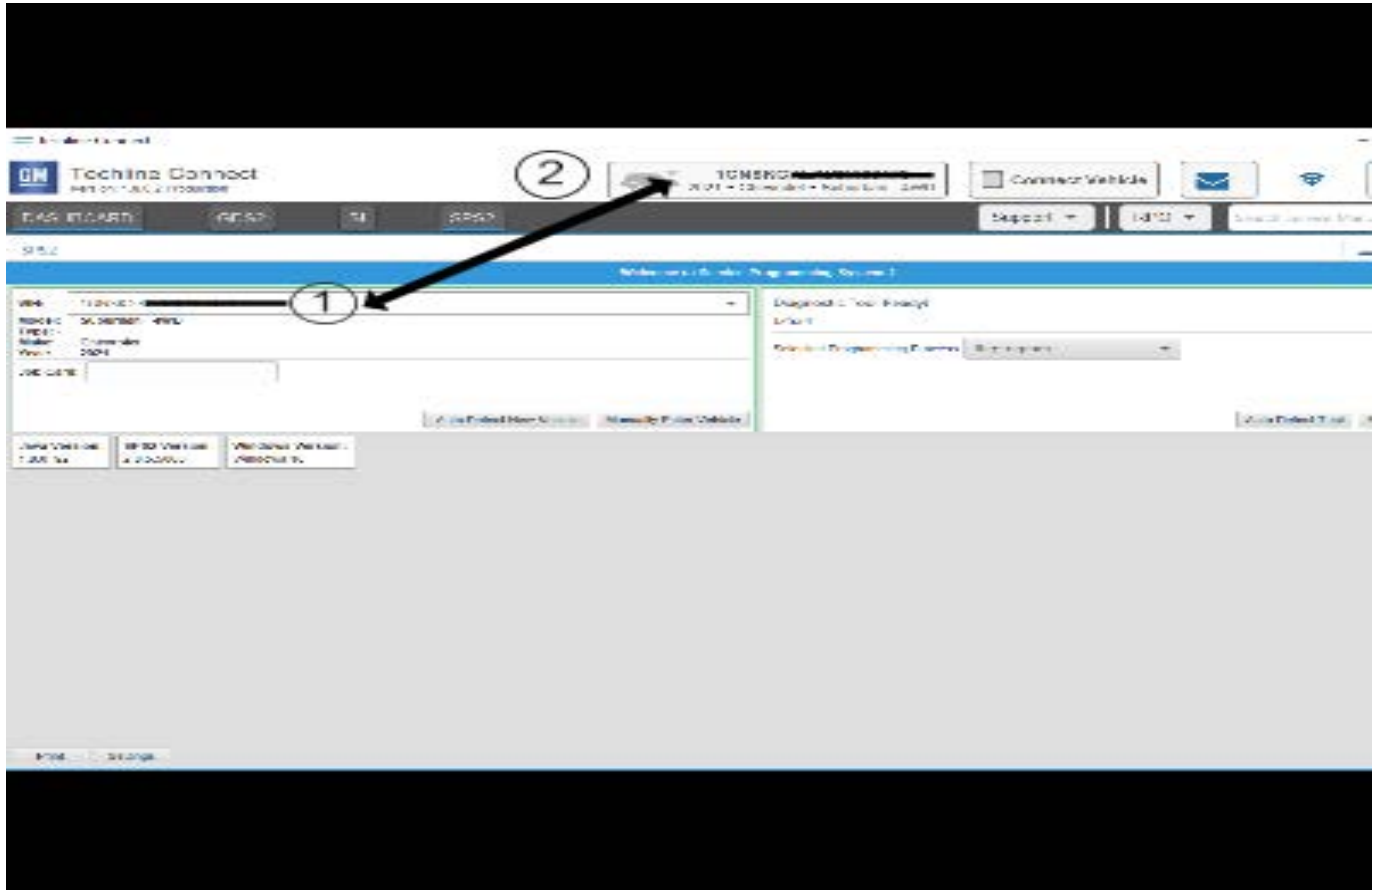
Caution: Be sure the VIN selected in the drop down menu (1) is the same as the vehicle connected (2) before beginning programming.

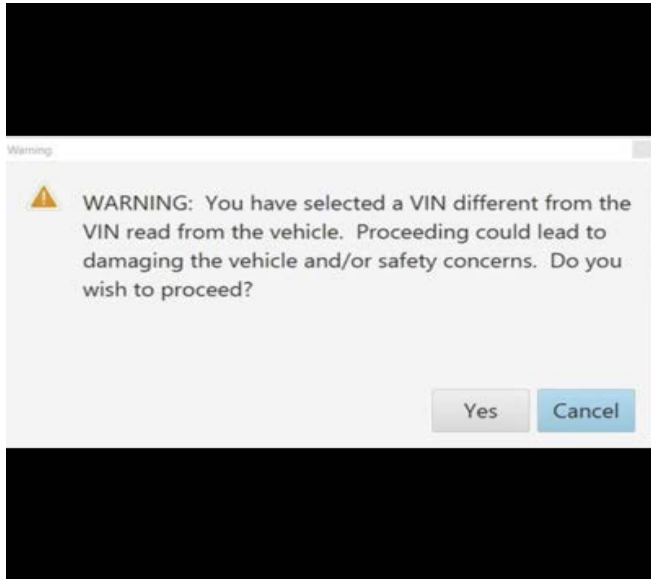
5877000

Important: If the vehicle VIN DOES NOT match, the message below will be shown

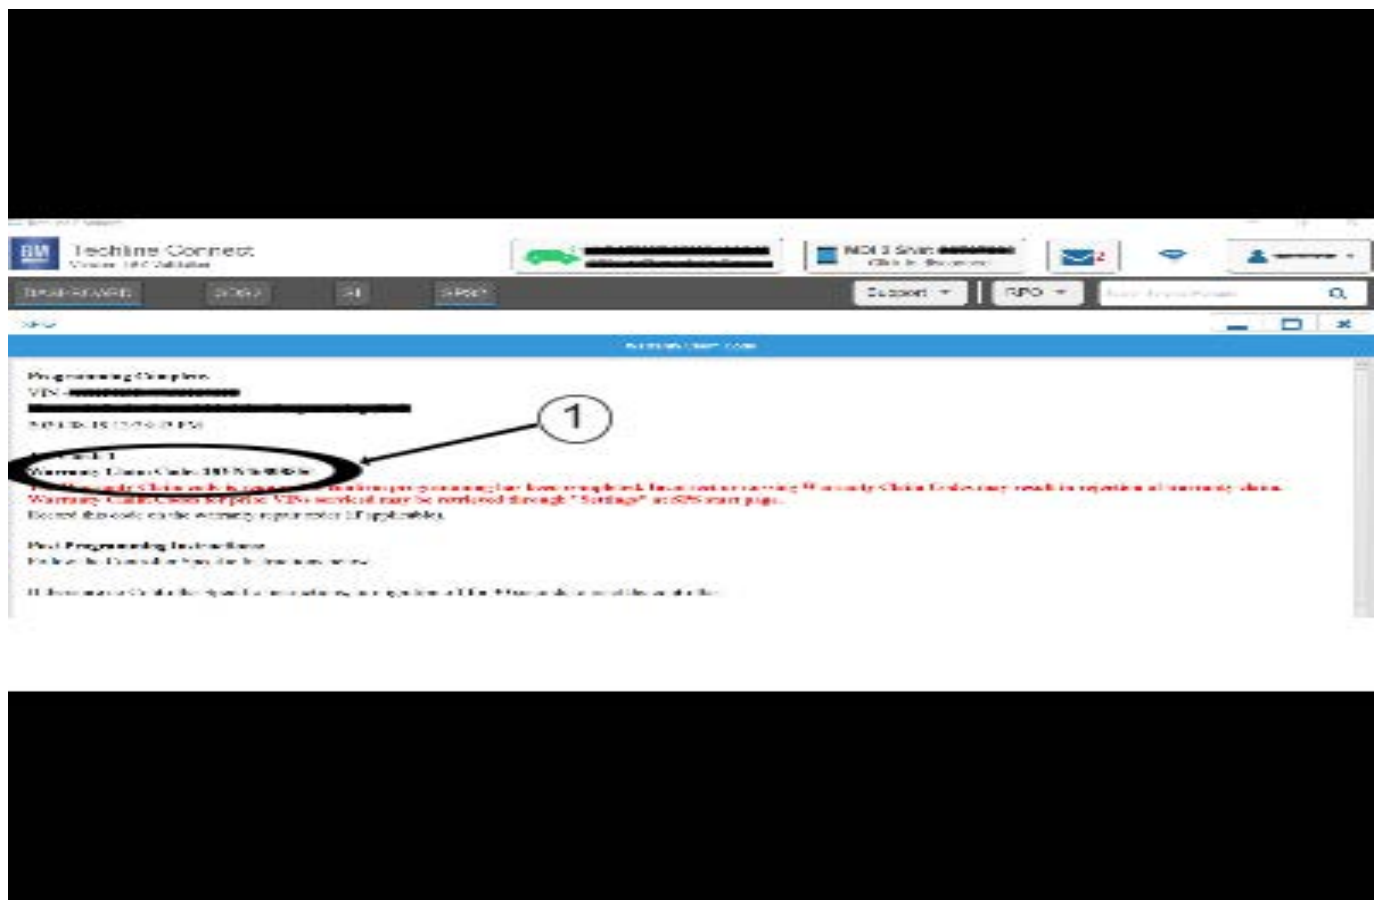
5644478

Important: To avoid warranty transaction rejections, you **MUST** record the warranty claim code provided on the Warranty Claim Code (WCC) screen shown above on the job card. Refer to callout 1 above for the location of the WCC on the screen.

2. Record Warranty Claim Code on job card for warranty transaction submission.

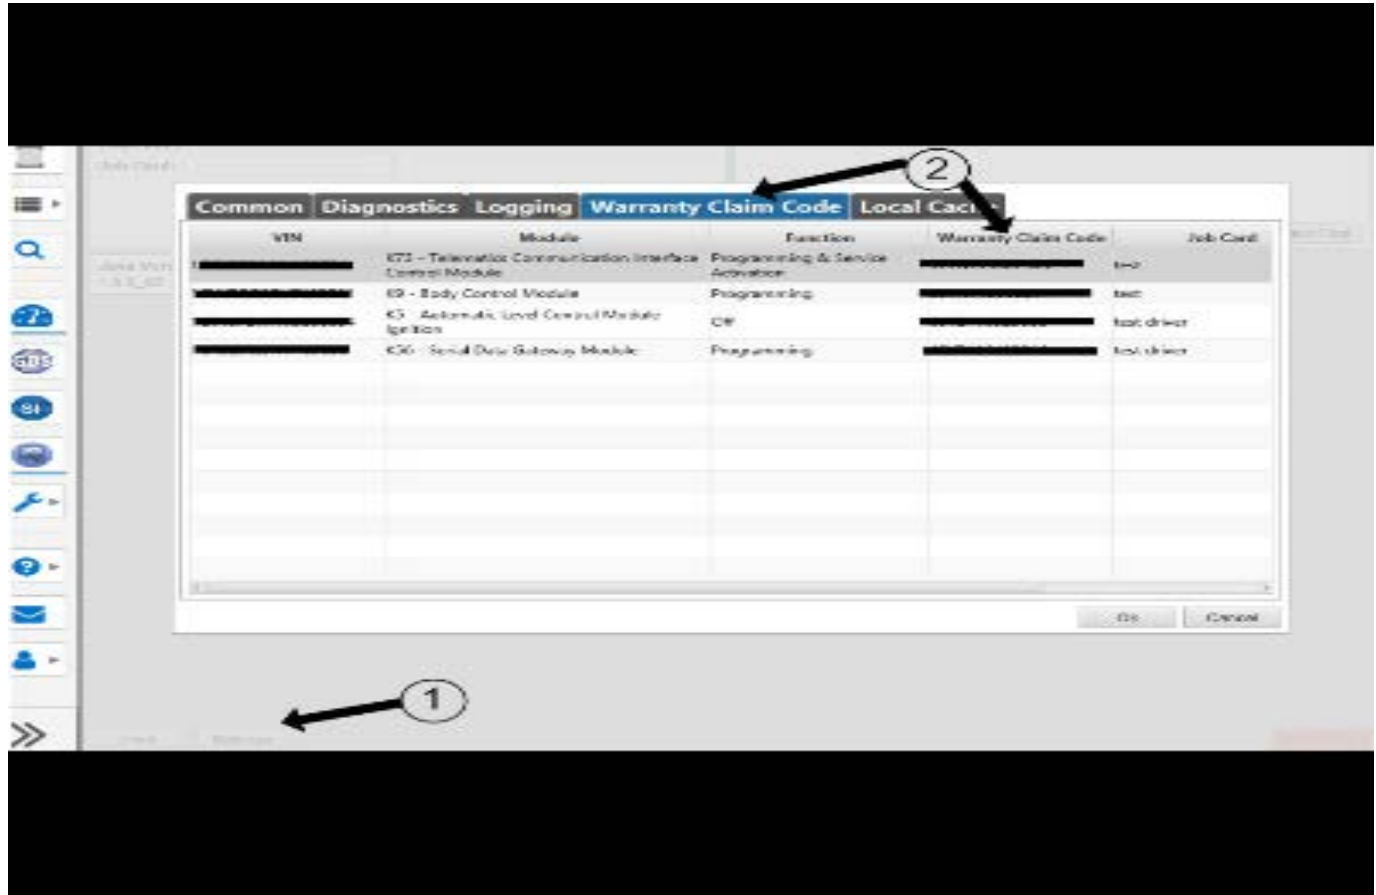
6125774

If the Warranty Claim Code was not recorded on the Job Card, the code can be retrieved in the SPS2 system as follows:

1. Open TLC on the computer used to program the vehicle.
2. Select and start SPS2.
3. Select Settings (1).
4. Select the Warranty Claim Code tab (2).
