# Technical Service Bulletin

**97 Q7 Various warnings or functions inoperative, corroded splice points in driver sill. DTC:**

**U150600,U028400, U020800**

47 22 17 2067722/1 August 26, 2022.

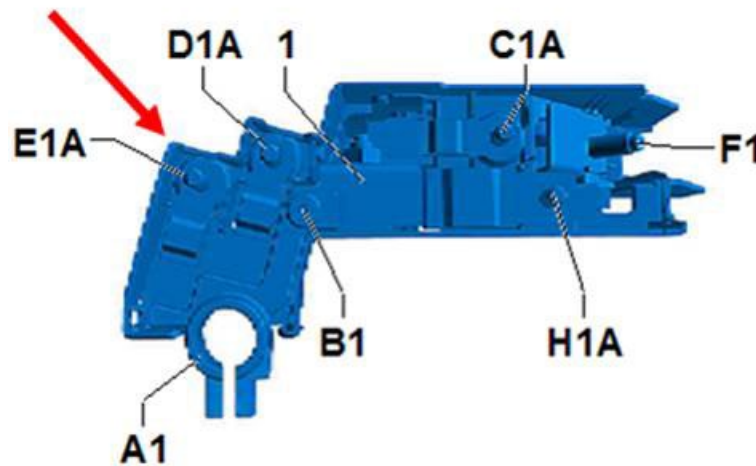
*Figure 3: Power supply location at the battery.*

- a. Test fit the repair cable in the vehicle.
- b. Disconnect the existing cable at E1A, and bolt the repair cable to the power supply terminal at the battery so that the cable end makes flat contact with the E1A terminal (Figure 3).

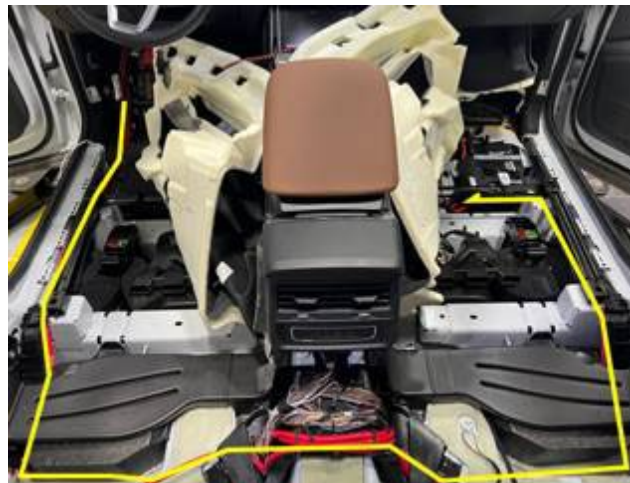
*Figure 4: Terminal 30 cable repair routing.*

- c. Route the repair cable along the factory routing path from the battery to the LF fuse block as indicated by the yellow line (Figure 4).
- d. Ensure sufficient slack and positioning is obtained along the entire routing path.

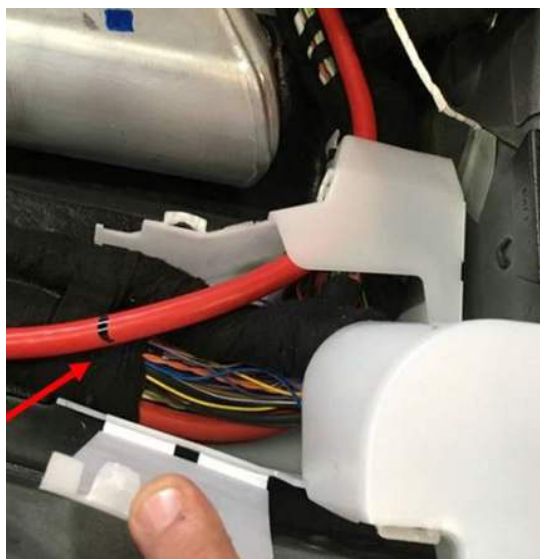
*Figure 5: The location is marked as indicated by the red arrow.*

- e. Mark the location on the repair cable just after the cable duct on the rear passenger side (Figure 5).
- f. This mark will be used in the next step as the indicator from the point to start wrapping the repair cable.

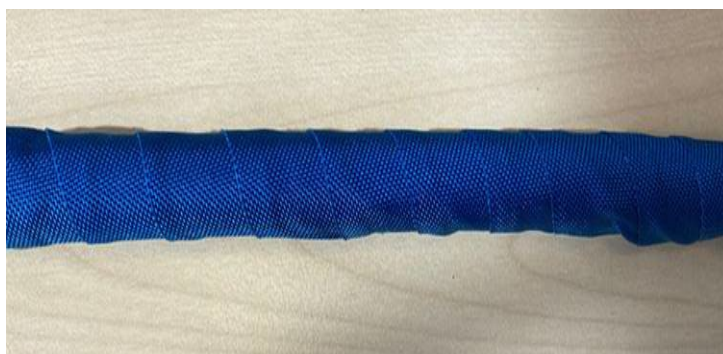
*Figure 6: Cable wrapping for N 107 292 04 (blue).*

- g. Remove the repair cable from the vehicle and wrap it with textile tape **N 107 292 04** (blue) between power distributor E1A at the battery to the marked location from the last step (Figure 6).

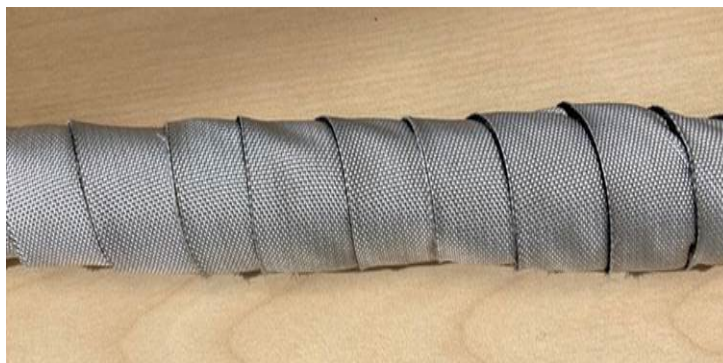
*Figure 7: Cable wrapping for N 107 516 03 Gray.*

- h. Next, wrap the same section of the repair cable again with textile tape **N 107 516 03** (gray) (Figure 7).

It is very important that the wrappings overlap by 50%. This wrapping is needed for crash requirements.

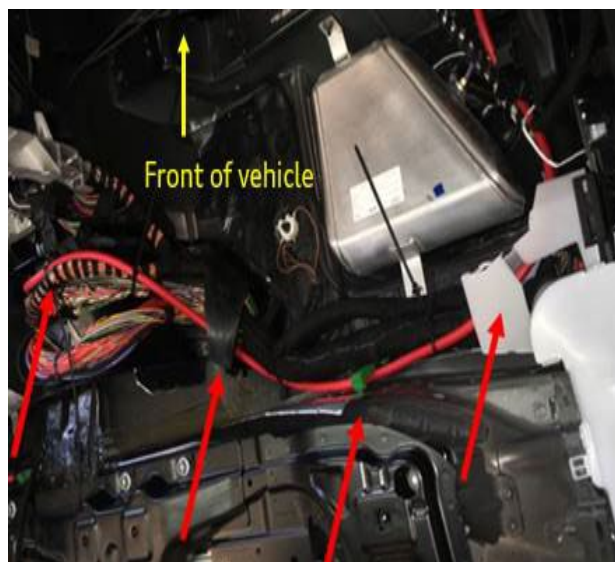
*Figure 8: Routing path passenger side. The lower portion of the photo is where the seat bottom mounts.*

- b. Route the repair cable into the wiring ducts on the rear passenger side (Figure 8) and the rear driver side (Figure 9).

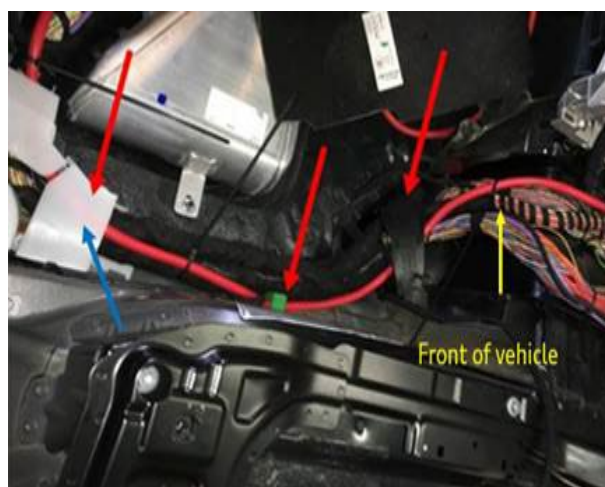
*Figure 9: Routing path driver side. The lower portion of the photo is where the seat bottom mounts.*

- c. Wrap the repair cable from the duct at the rear drive side (Figure 9) all the way to the last junction point of the repair cable nearest the fuse box.

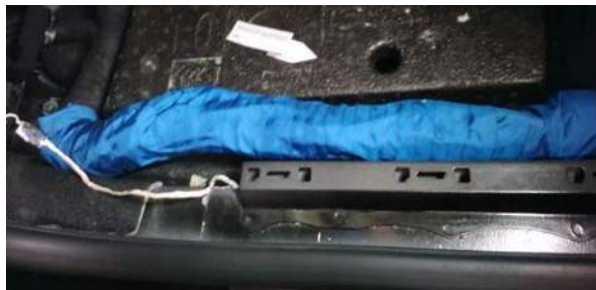
*Figure 10: Main wiring harness wrapped with blue textile tape.*

- a. The original supply cable does not need to be fully removed from the interior wiring harness.
  - Once disconnected, cut the original cable end off at the E1A connection point at the battery. Seal the end with textile tape **N 107 290 02** and wrap the remaining wire securely onto the interior wiring harness
  - Cut the original power supply wires back in the area of the driver's door sill, ensuring sufficient working space. Seal ends which are cut off with textile tape **N 109 290 02**.
- b. Wrap the entire main wiring harness (including repair cable) between the A and B pillars both on the driver and passenger sides. First wrap with blue textile tape **N 107 292 04** (Figure 10).

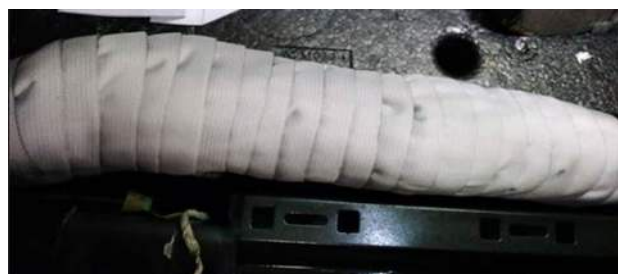
*Figure 11: Gray textile tape covering the already wrapped main wiring harness.*

- c. Then rewrap with gray textile tape **N 107 516 03** (Figure 11).
