97 Q8 Various warnings or functions inoperative, corroded splice points in driver sill. DTC: U150600,U028400, U020800

97 22 85 2067785/1 August 26, 2022.

| Model(s) | Year | VIN Range | Vehicle-Specific Equipment |
|---|---|---|---|
| Q8 | 2019 – 2023 | All | Not Applicable |
| SQ8 and RS Q8 | 2020 – 2023 | | |

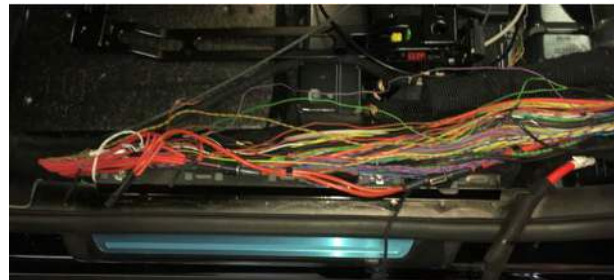
*Figure 2: Driver side door sill area, open harness to expose splice points.*

- a. De-energize the vehicle before beginning repair.
- b. Carefully open the harness tape of the main vehicle harness located in the area between the A-Pillar and the B-Pillar on the driver's side (Figure 2).

- a. All splice points in this area must be serviced with VAS 1978 B, ensuring that they are watertight.

**Non-oxidized splice points:** Seal the splice points using shrinking end caps.

**Oxidized splice points:** Service with VAS 1978 B. Ensure that repaired splice points are watertight.

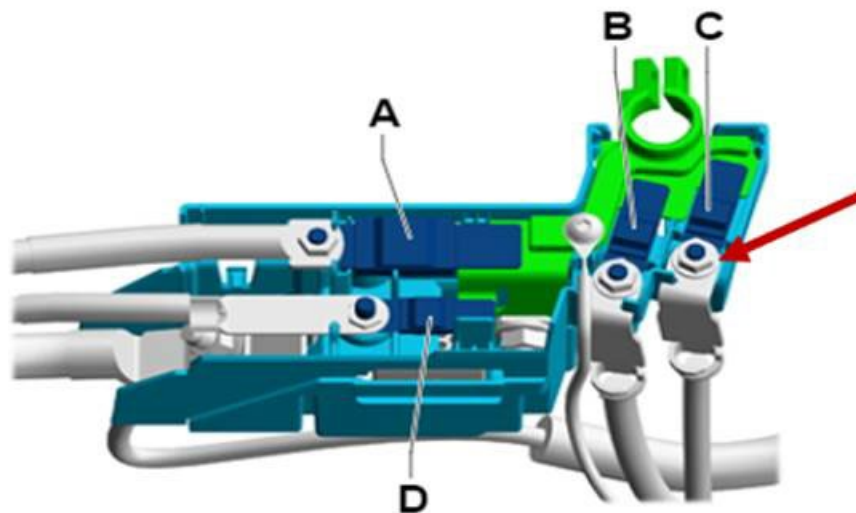
*Figure 3: Power supply location at the battery; "C" indicated with the red arrow.*

- a. Test fit the repair cable in the vehicle.
- b. Disconnect the existing cable at **C**, and bolt the repair cable to the power supply terminal at the battery so that the cable end makes flat contact with the **C** terminal (Figure 3).

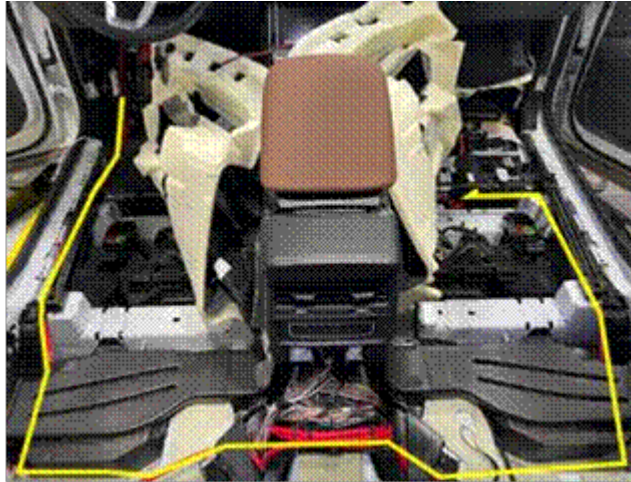
*Figure 4: Terminal 30 cable repair routing.*

- c. Route the repair cable along the factory routing path from the battery to the LF fuse block as indicated by the yellow line (Figure 4).

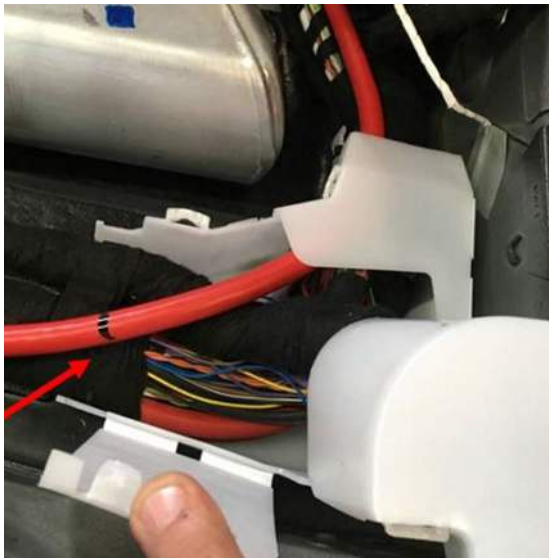
*Figure 5: The location is marked as indicated by the red arrow.*

- e. Mark the location on the repair cable just after the cable duct on the rear passenger side (Figure 5).
- f. This mark will be used in the next step as the indicator from the point to start wrapping the repair cable.

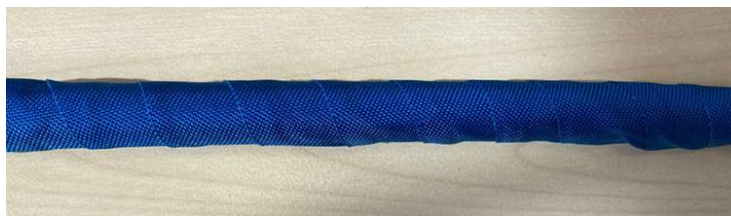
*Figure 6: Cable wrapping for N 107 292 04 (blue).*

- g. Remove the repair cable from the vehicle and wrap it with textile tape **N 107 292 04** (blue) between power distributor **C** at the battery to the marked location from the last step (Figure 6).

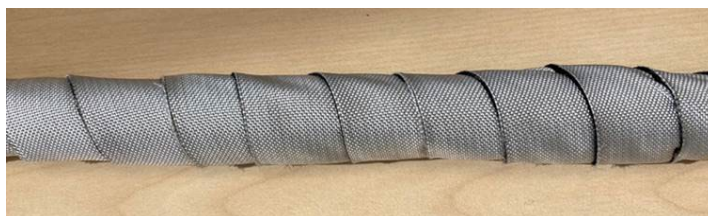
*Figure 7: Cable wrapping for N 107 516 03 Gray.*

- h. Next, wrap the same section of the repair cable again with textile tape **N 107 516 03** (gray) (Figure 7). It is very important that the wrappings overlap by 50%. This wrapping is needed for crash requirements.

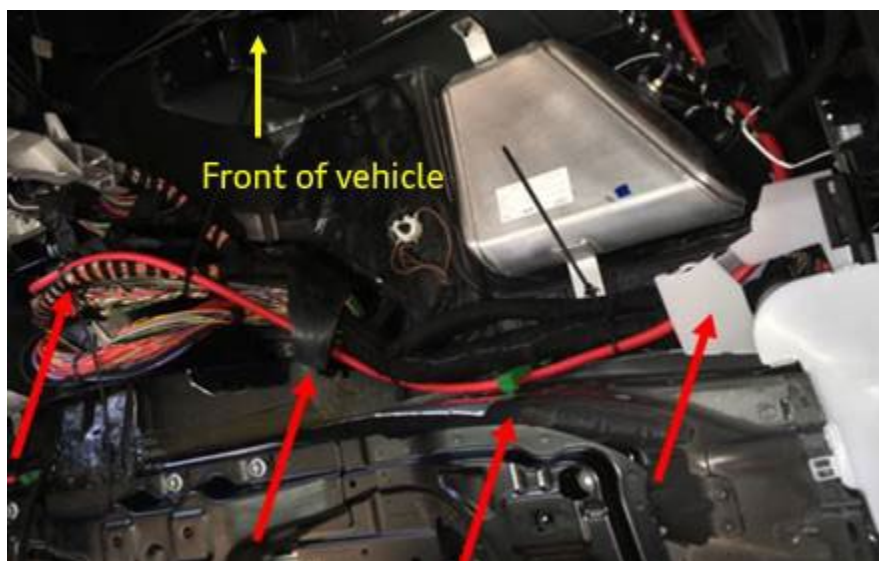
*Figure 8: Routing path passenger side. The lower portion of the photo is where the sea bottom mounts.*

- b. Route the repair cable into the wiring ducts on the rear passenger side (Figure 8) and the rear driver side (Figure 9).

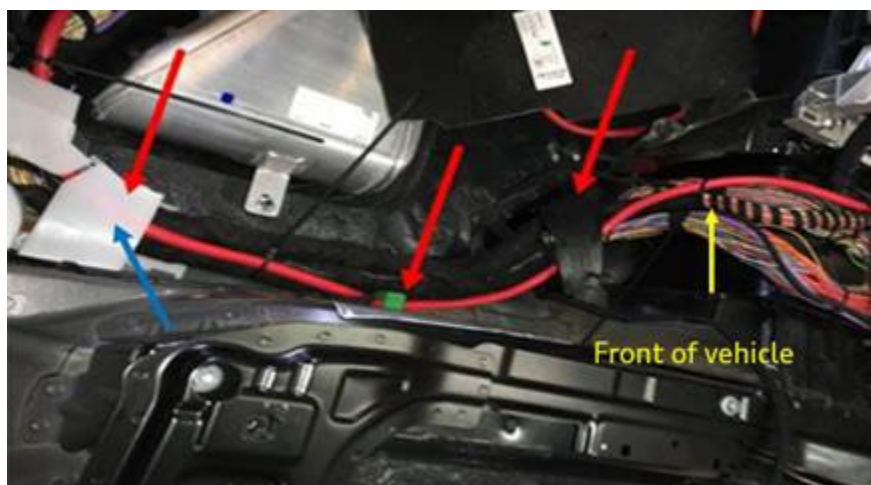
*Figure 9: Routing path driver side. The lower portion of the photo is where the seat bottom mounts.*

- c. Wrap the repair cable from the duct at the rear drive side (Figure 9) all the way to the last junction point of the repair cable nearest the fuse box.

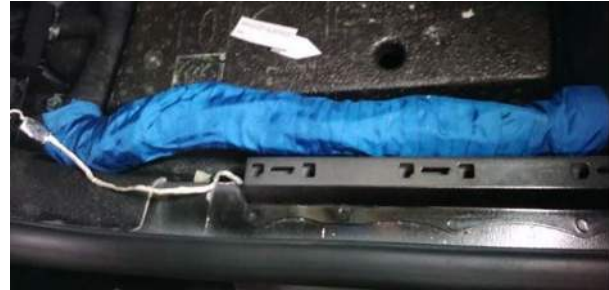
*Figure 10: Main wiring harness wrapped with blue textile tape.*

- b. Wrap the entire main wiring harness (including repair cable) between the A and B pillars both on the driver and passenger sides. First wrap with blue textile tape N 107 292 04 (Figure 10).

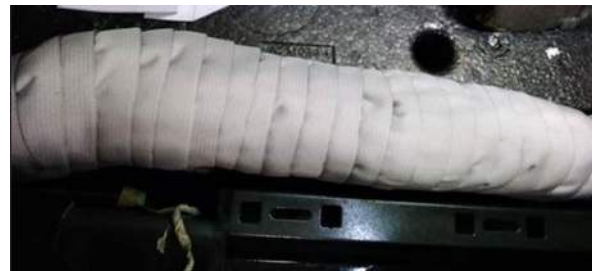
*Figure 11: Gray textile tape covering the already wrapped main wiring harness.*

- c. Then rewrap with gray textile tape N 107 516 03 (Figure 11).
