# Technical Service Bulletin

97 Q8 Various warnings or functions inoperative, corroded splice points in driver sill. DTC: U150600,U028400, U020800

97 22 86 2067785/2 August 29, 2022. Supersedes Technical Service Bulletin Group 97 number 22-85 dated August 26, 2022, for reasons listed below.

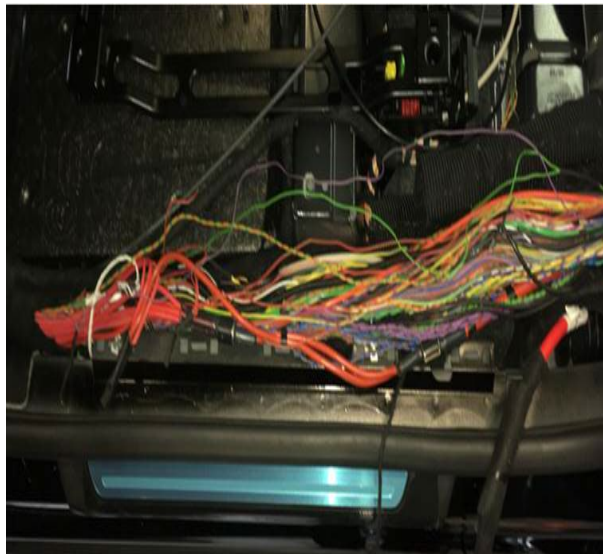
*Figure 1: Seam ripper.*

**Tip:** A locally sourced seam ripper is useful for this task. Avoid using a razor blade as this will likely cause unintended cuts in the wires.
