# TECHNICAL SERVICE BULLETIN

| AT21-003B | NTB21-023B | August 30, 2022 |

## DTC P0780 STORED IN THE TCM

**APPLIED VEHICLES:** 2021 Rogue (T33)

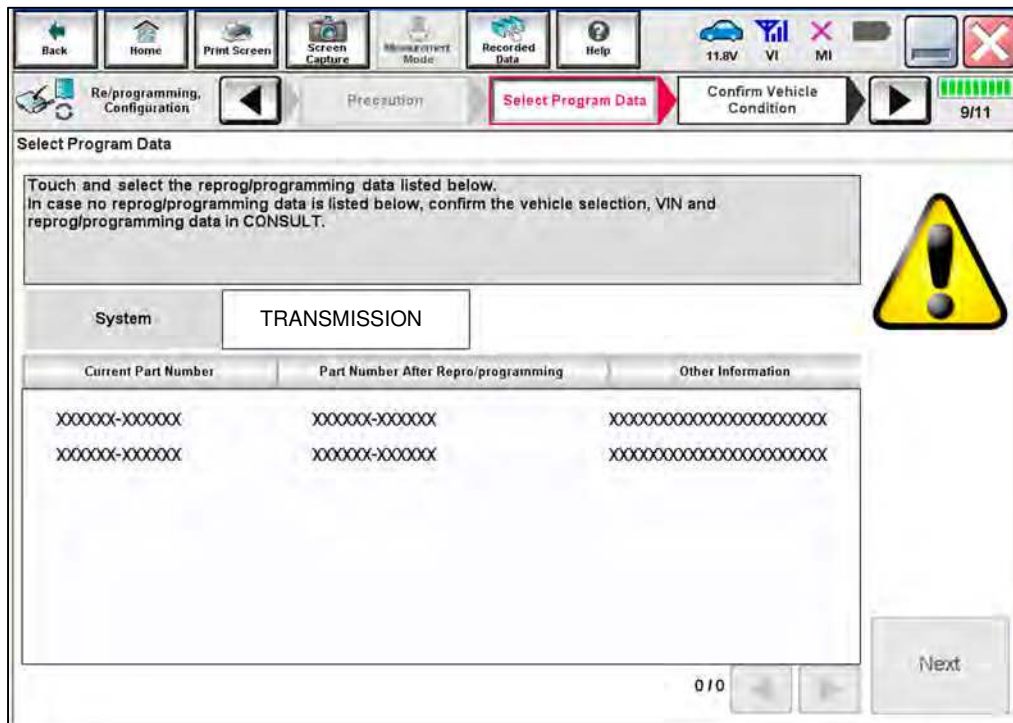
- If more than one new P/N is available, the screen in Figure 11 displays.
- Select and use the reprogramming option that does **not** have the message “Caution! Use ONLY with NTBXX-XXX”.
- If you get this screen and it is blank (no reprogramming listed), it means there is no reprogramming available for this vehicle. Skip to step 25 on page 13.

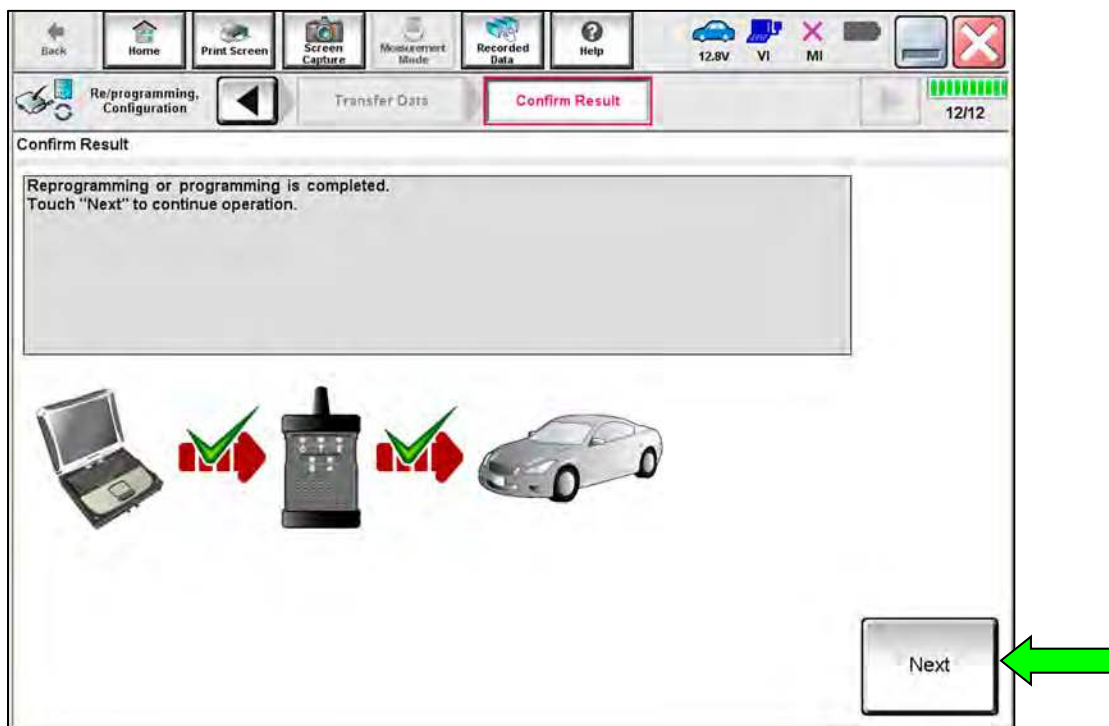
**NOTE:** When the screen in Figure 14 displays, reprogramming is complete. If the screen in Figure 14 does not display (indicating that reprogramming did not complete), refer to the information on the next page.

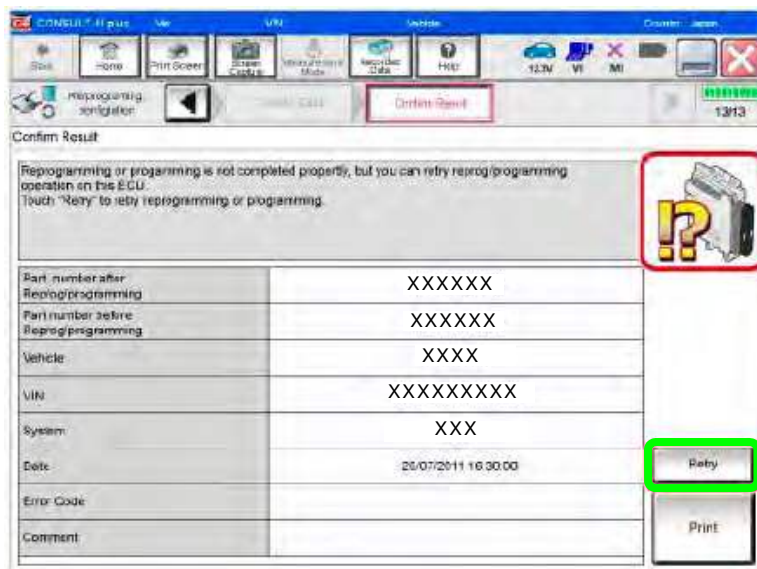
Figure 15

If reprogramming does not complete, and the “!?” icon displays as shown in Figure 15:

- Check battery voltage (12.0 V – 15.5 V).
- Ignition is ON, engine is OFF.
- External Bluetooth® devices are OFF.
- All electrical loads are OFF.
- Select retry and follow the on screen instructions.
- “Retry” may not go through on first attempt and can be selected more than once.

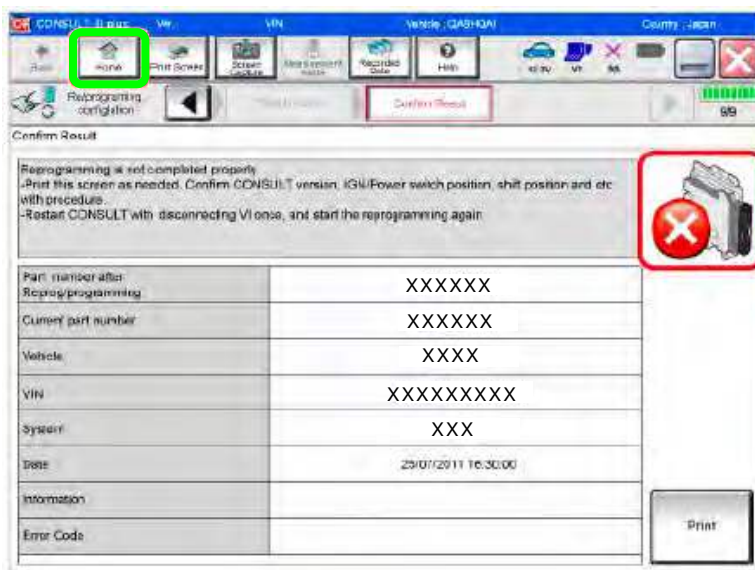
Figure 16

If reprogramming does not complete, and the “X” icon displays as shown in Figure 16:

- Check battery voltage (12.0 V – 15.5 V).
- CONSULT A/C adapter is plugged in.
- Ignition is ON, engine is OFF.
- Transmission is in Park.
- All C-III plus / VI cables are securely connected.
- All C-III plus updates are installed.
- Select Home, and restart the reprogram procedure from the beginning.
