## Technical product information

| <b>Topic</b> | New Continental GT, GTC, New Flying Spur - Blind spot monitors not functional DTC C1114F3 logged in address 003C or 00CF |
| <b>Transaction No.</b> | 2062884/4 |

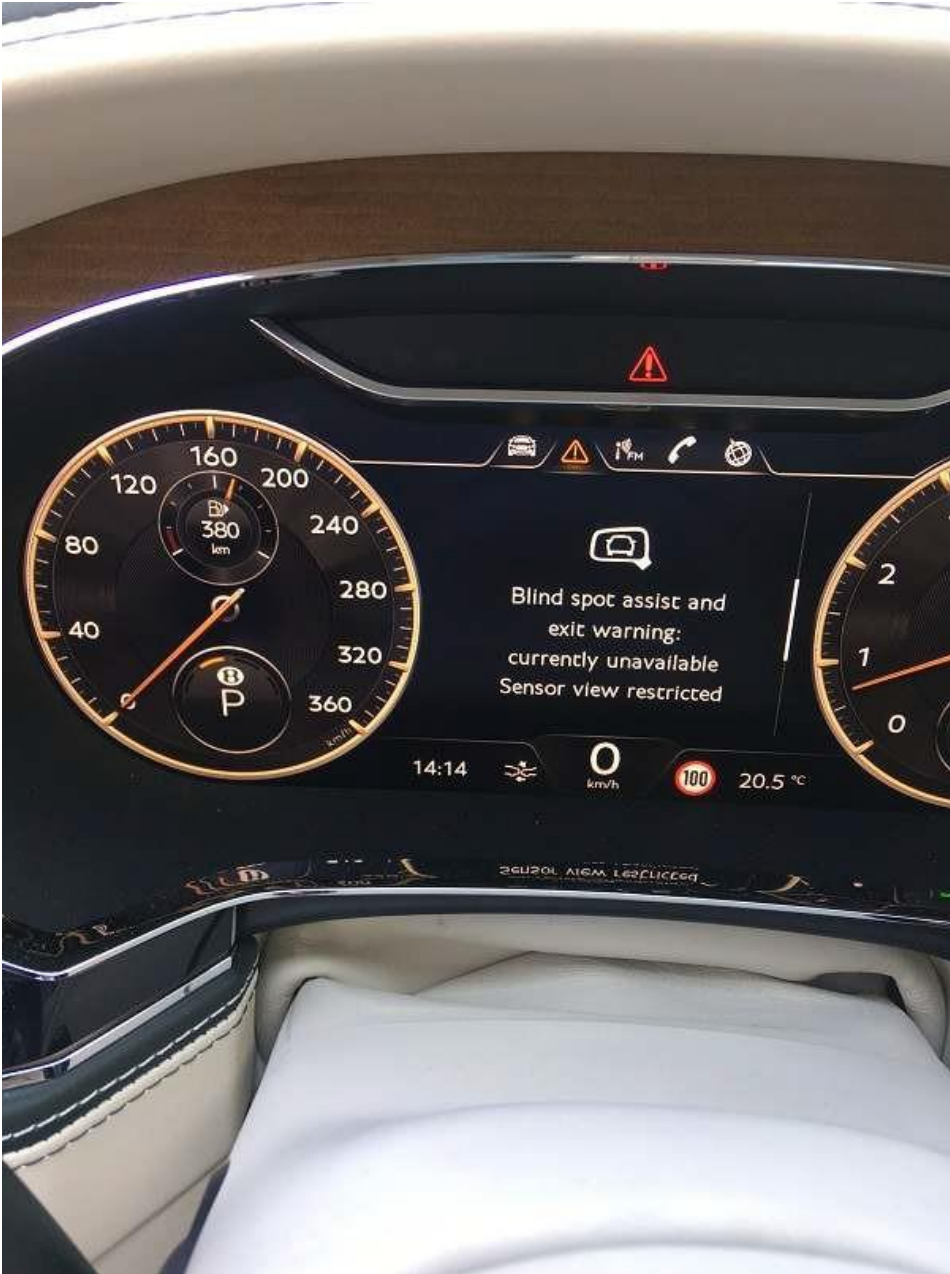
Figure 1

Blind spot monitors (Wing mirror illuminations) are not functional in conjunction with sporadic Bentley assist warnings present in the DIP (Figure 1)

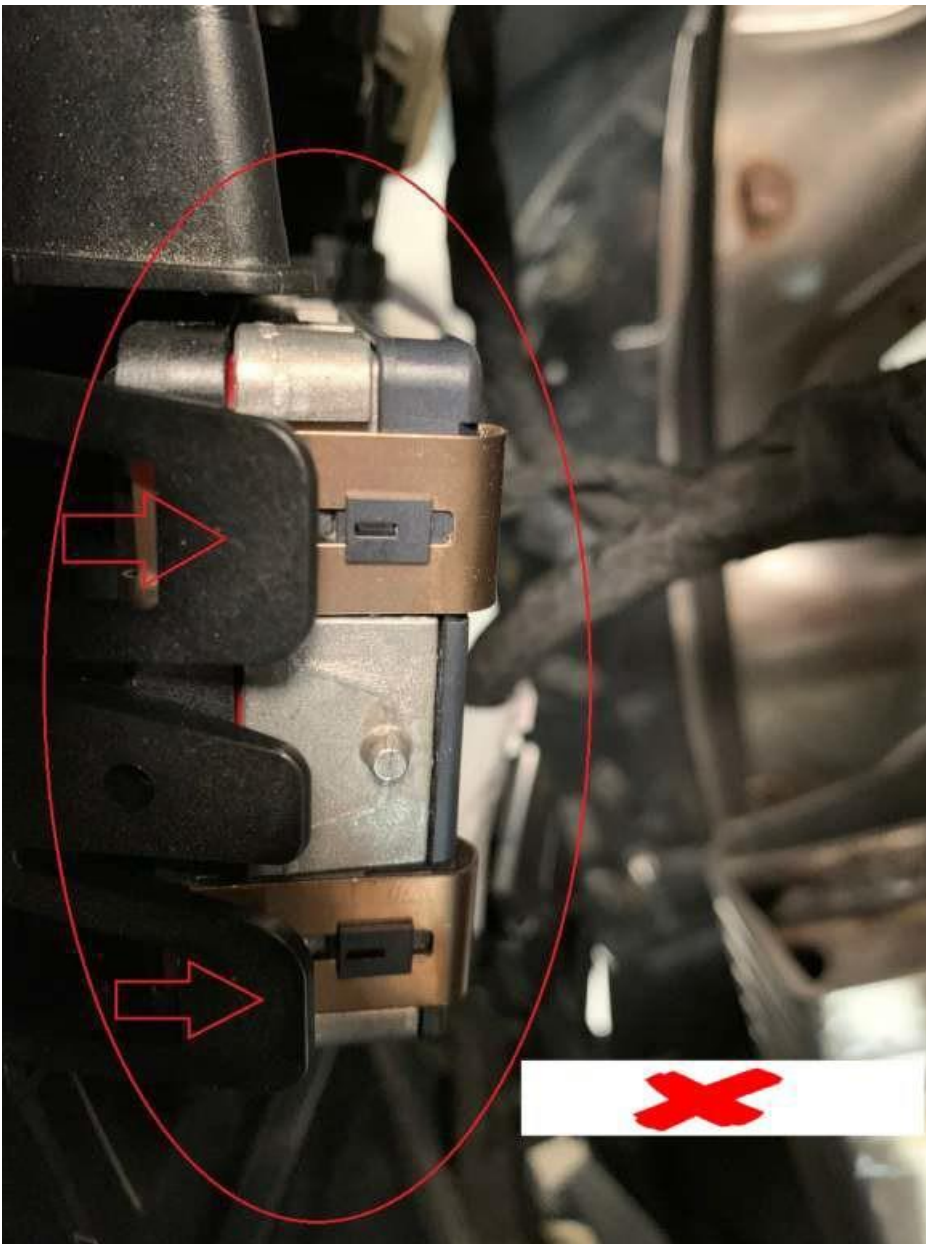
Figure 2

Master or slave rear radars are not fitted correctly (unclipped or poorly installed)

- 003C: Inspect the RHS rear radar fitment and/or bracket damage
- 00CF: Inspect the LHS rear radar fitment and/or bracket damage

3) In the event one or both control units are loose/detached - Refer to Figures 2 (Before adjustment) and 3 (After adjustment) and also reference Rep.Gr - 44 Lane change assist control units (J769 and J770) - To remove and fit
