# Service Bulletin

Bulletin No.: 22-NA-084

Subject: Information on Unable to Open Folding Top, DTC B19E1 sym64 Possibly Set

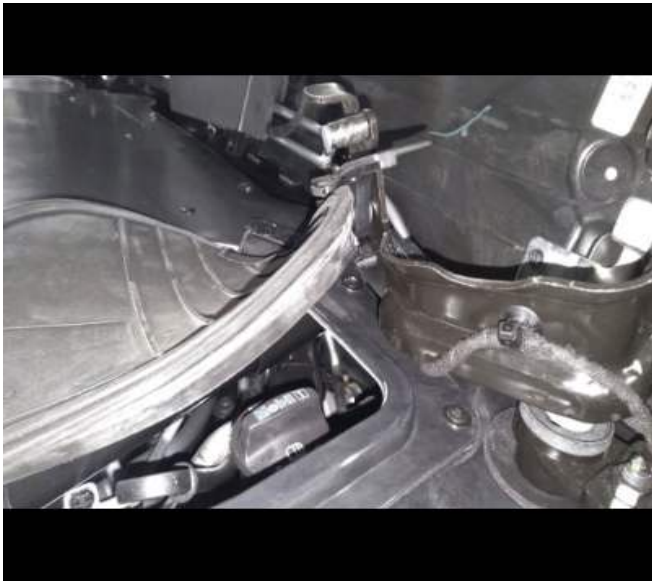
| Cause | <p>6039905</p> <p>The cause of the condition may be that the body side frame access hole plug may not have been seated properly. This may lead to the plug interfering with B373 Folding Top Side Rail - Roof Panels Stowed Sensor.</p> <p>Note: The body side frame access hole plug must be fully seated whenever the plug is removed.</p> |

| Correction | <ol style="list-style-type: none"><li>1. First gain access to the body side frame access hole plug. Refer to Opening the Folding Top Stowage Compartment Lid — Engine Access section within Folding Top and Folding Top Stowage Compartment Lid Operation in the Service Manual.</li><li>2. Inspect the body side frame access hole plug to assure it is fully seated.</li></ol> <p>Note: The customer should be informed to ensure the access plug is secured, and fully seated, before driving the vehicle whenever the oil or coolant is checked. Please share this information with the customer, including a copy of this bulletin.</p> |
