# MIL ON With DTC P019064

**Service Category** Engine/Hybrid System

**Section** Engine Control

Some 2019 model year ES 300h and UX 250h vehicles may exhibit a MIL ON condition with Diagnostic Trouble Code (DTC) P019064 (Fuel Rail Pressure Sensor “A” Signal Plausibility Failure). The Engine Control Module (ECM) (SAE term: Powertrain Control Module/PCM) logic has been modified to reduce the possibility of this condition. Follow the Repair Procedure in this bulletin to address this condition.

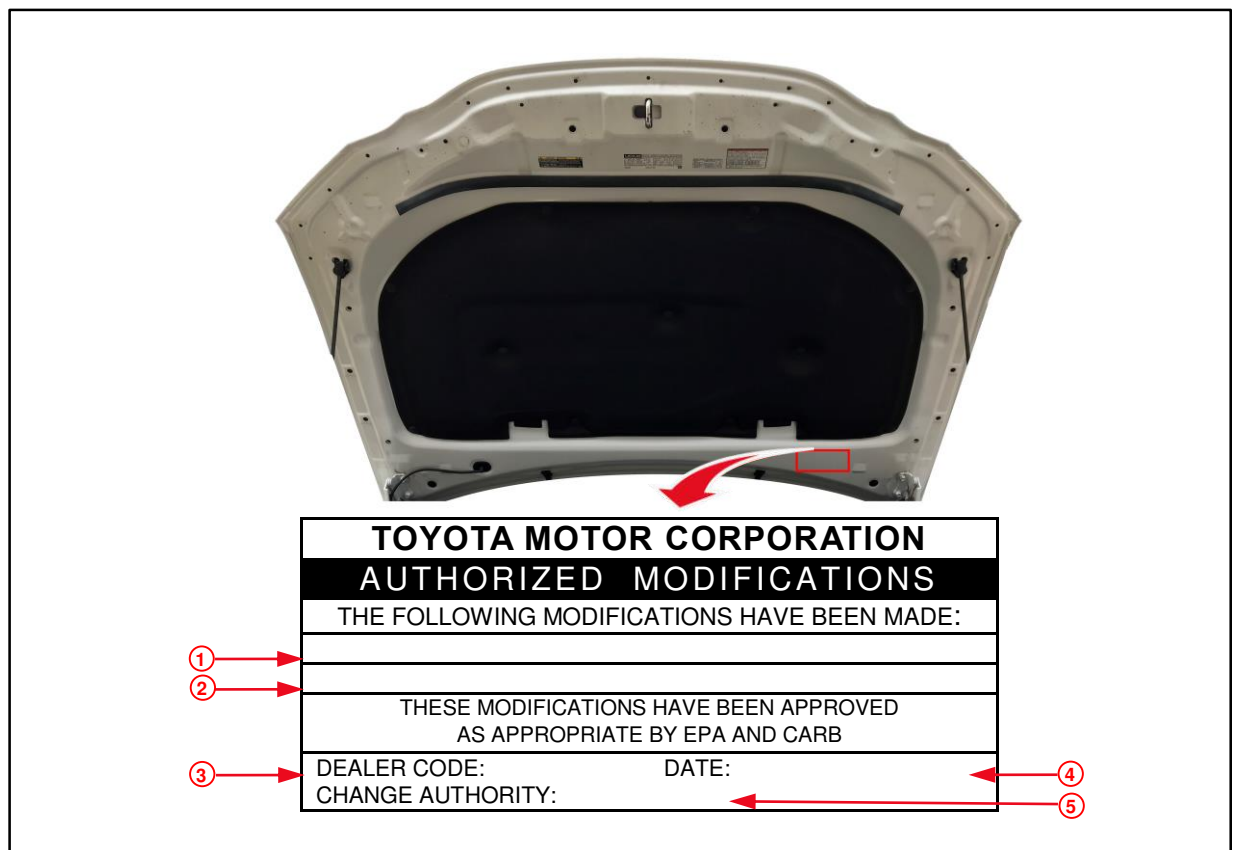
**Figure 1. Location of Authorized Modifications Label on 2019 ES 300h**

2. Use Techstream to confirm if the ECM (PCM) calibration has been updated and check for the Authorized Modifications Label affixed to the vehicle in the locations shown in Figures 1 and 2.

4. Prepare and install the Authorized Modifications Label.
  - A. Using a permanent marker, enter the following information on the label:
    - ECM (PCM) part number [*Refer to the **Parts Information** section for the **NEW PART NUMBER***]
    - Calibration ID(s) [*Refer to the **Calibration Information** section for the **NEW CALIBRATION ID***]
    - Dealer Code
    - Repair Date
    - Change Authority [***This bulletin number***]
  - B. Install the Authorized Modifications Label onto the vehicle at the locations shown in Figures 1 and 2. The Authorized Modifications Label is available through the MDC, P/N 00451-00001-LBL.
