# MIL ON With DTC(s) P0D2A19, P1C1B00, P0E8919, and/or P1BD300 and Inoperative Onboard Plug-in Charger

| YEAR(S) | MODEL(S) | ADDITIONAL INFORMATION |
|---|---|---|
| 2021 - 2022 | RAV4 Prime | |

Some 2021 – 2022 model year RAV4 Prime XSE grade vehicles equipped with a 6.6 kW electric vehicle charger sub-assembly may exhibit a MIL ON condition with one or more of the following Diagnostic Trouble Codes (DTCs):

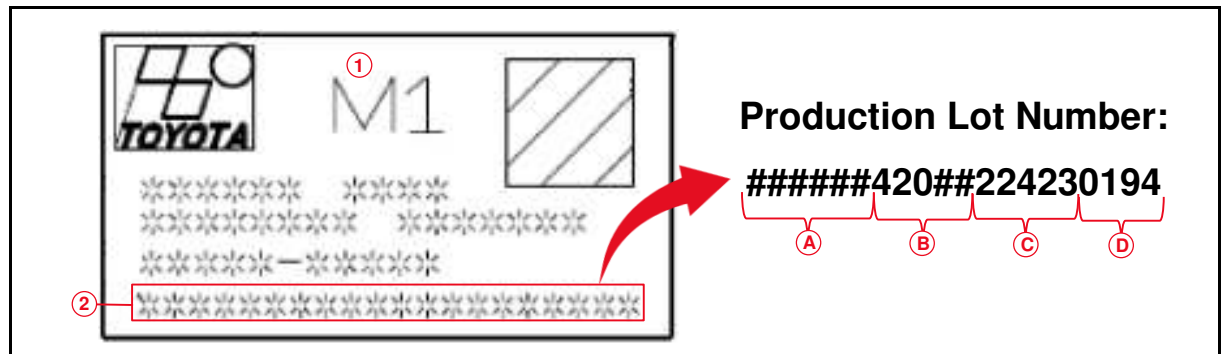
**Figure 1. Label**

2. Locate the electric vehicle charger sub-assembly in the vehicle and refer to the attached part label production lot number.
3. Confirm the vehicle is equipped with a 6.6 kW electric vehicle charger sub-assembly.

Are the last five digits of the part number listed on the label 42050, 42051, 42060, or 42061?

Are the last nine digits of the production lot number listed on the label less than 224230194?

5. Remove the electric vehicle charger sub-assembly.  
Refer to TIS, applicable model and model year Repair Manual:
  - [2021](#) / [2022](#) RAV4 Prime:  
*Engine/Hybrid System – Hybrid/Battery Control System – “Hybrid / Battery Control: Electric Vehicle Charger Assembly: Removal”*
6. Install the NEW electric vehicle charger sub-assembly.  
Refer to TIS, applicable model and model year Repair Manual:
  - [2021 – 2022](#) RAV4 Prime:  
*Engine/Hybrid System – Hybrid/Battery Control System – “Hybrid / Battery Control: Electric Vehicle Charger Assembly: Installation”*
7. Using Techstream, clear ANY DTCs and confirm the condition is no longer present.
