# Technical Service Bulletin

## 87 Air Conditioning is inoperative, DTC B11AE15

87 22 32 2067362/2 September 20, 2022. Supersedes Technical Service Bulletin Group 97 number 22-84 dated June 22, 2022,  
for reasons listed below.

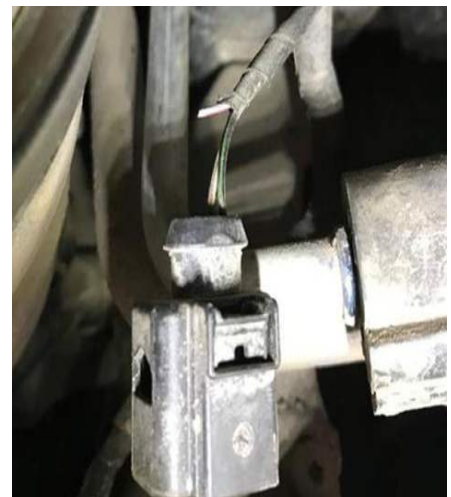
The wiring to the A/C compressor connector T3r is not long enough. Wires may become stretched, broken, or pulled from the connector as a result.

If DTC B11AE15: A/C compressor regulator valve Open circuit/short circuit to B+ is stored in the onboard supply control unit J519 diagnostic address 0009, inspect the wiring at connector T3r in the area of the A/C compressor as seen in Figure 1.

*Figure 1. N280 control wire damaged at T3r connection*

If damage is found in this area, all 3 wires will need to be extended following the directions below.
