## STAR ONLINE PUBLICATION

**Case Number: S2018000007 REV. B**

**Symptom/Vehicle Issue:** Diagnostic Trouble Code (DTC) P0299 – Turbocharger Underboost Additional Diagnostics

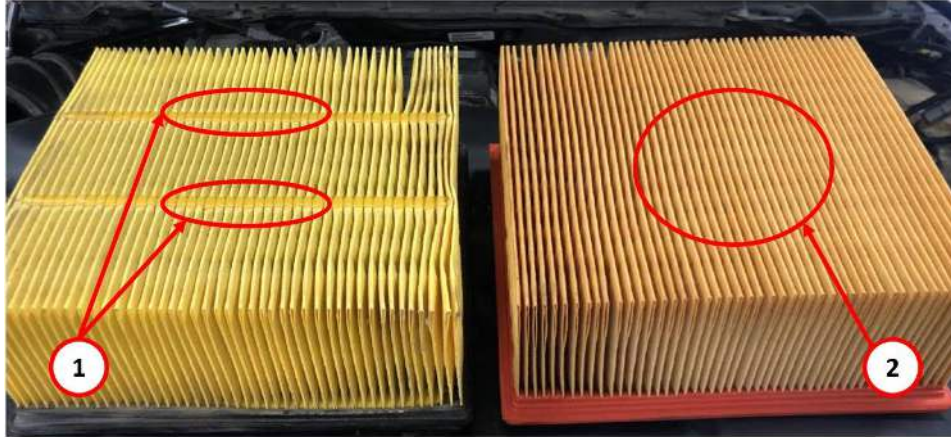
**Figure 1**

1. Remove, and inspect the engine air filter. Ensure that the air filter is clean, and not restricted.
2. Inspect the bottom of the air filter to see if it utilizes glue strips to separate the pleats. Newer design OEM replacement air filters, and some aftermarket filters utilize glue strips to separate the pleats. Please see ([Figure 1](#)). There have been reports that filters using this design can potentially cause this DTC. If the air filter installed on the vehicle utilizes these glue strips, swap it with one that is not equipped with them, and retest.

1. Glue Strips
2. No Glue Strips

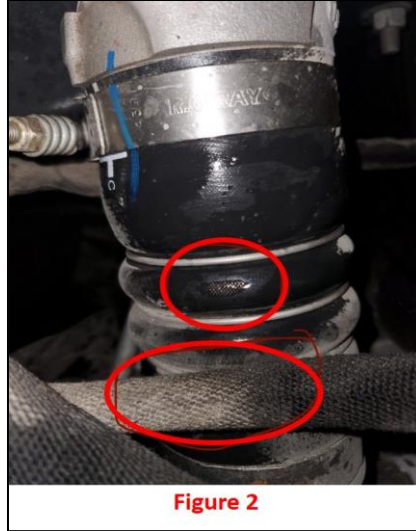
Figure 2

3. Ensure that the Charge Air Cooler (CAC) system is properly pressure tested per the steps outlined in Service Library Service Information Section 09 – Engine, 6.7L Diesel > Turbocharger System > Diagnosis and Testing – Leaks. While performing the CAC leak testing, pay close attention to the CAC boot connected to the turbo outlet for leaks caused by the wire harness rubbing through the boot. Please see (Figure 2).

4. If the boot is found damaged, replace as necessary, and retest the CAC system for any additional leaks. Repair as necessary.
5. Remove the EGR Crossover tube from the EGR valve, and inspect the EGR inlet to see if there are signs that the valve internal seat has begun to rotate. Please see (Figure 3). The EGR internal shaft should be completely visible when looking into the crossover tube inlet.

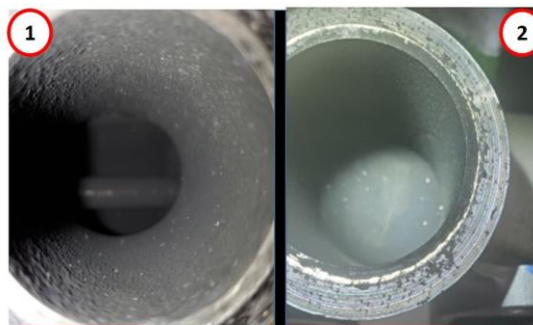
Figure 3

1. Healthy part    2. EGR with rotated seat

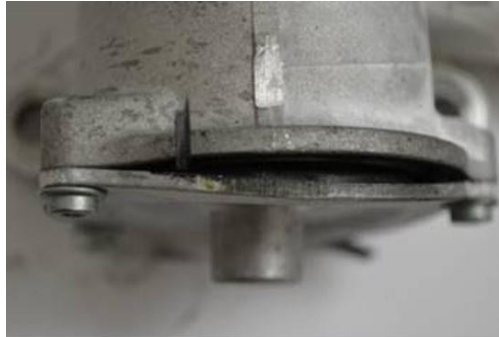
**Figure 4**

6. Thoroughly inspect the EGR valve end cap for signs of leaks (**Figure 4**). If found to be leaking, replace the EGR valve.
