**NUMBER:** 18-010-21

Flash: Powertrain Control Module (PCM) Updates

This bulletin involves reprogramming the Engine Control Module (ECM) / Powertrain Control Module (PCM) with the latest available software.

| 2019 | (DJ) | RAM 2500 Pickup |

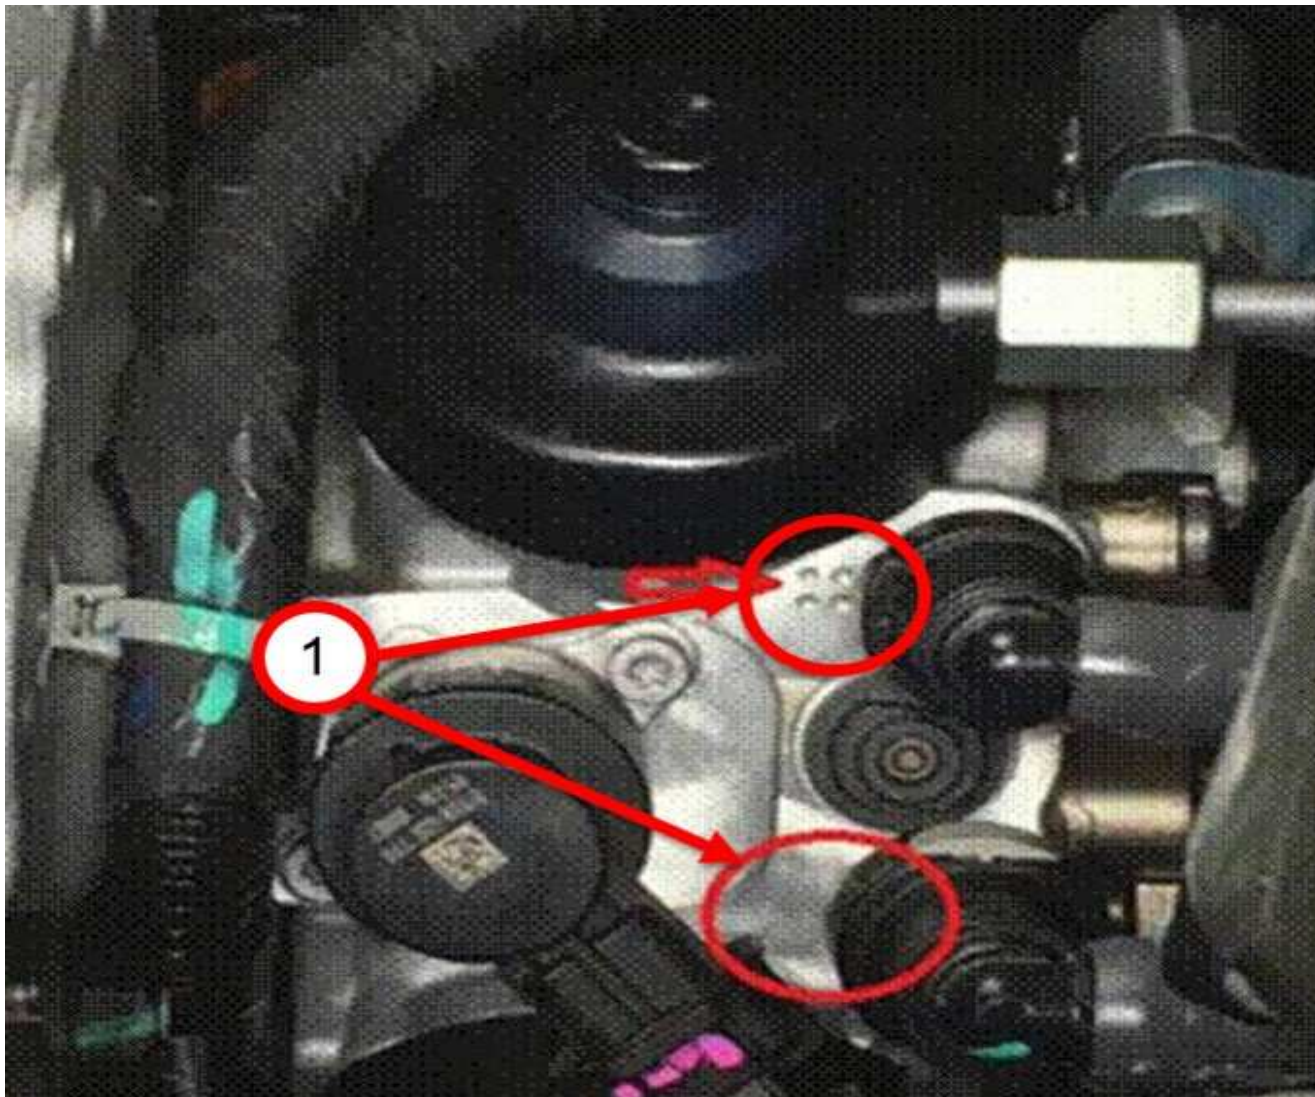
**Fig. 2**  
**Old Style Asymmetrical Cam Design Pump**

- Vehicles with the old style Asymmetrical Cam design will have multiple dots embossed in the pump housing (Fig. 2) .
- For vehicles with an Asymmetrical Cam pump, choose the calibration labeled Asymmetric Cam or Asym Cam.

1 - Multiple Dots on Housing
