**NUMBER:** 18-011-21

**GROUP:** 18 - Vehicle Performance

Flash: Powertrain Control Module (PCM) Updates

This bulletin involves reprogramming the Engine Control Module/Powertrain Control Module (ECM/PCM) with the latest available software.

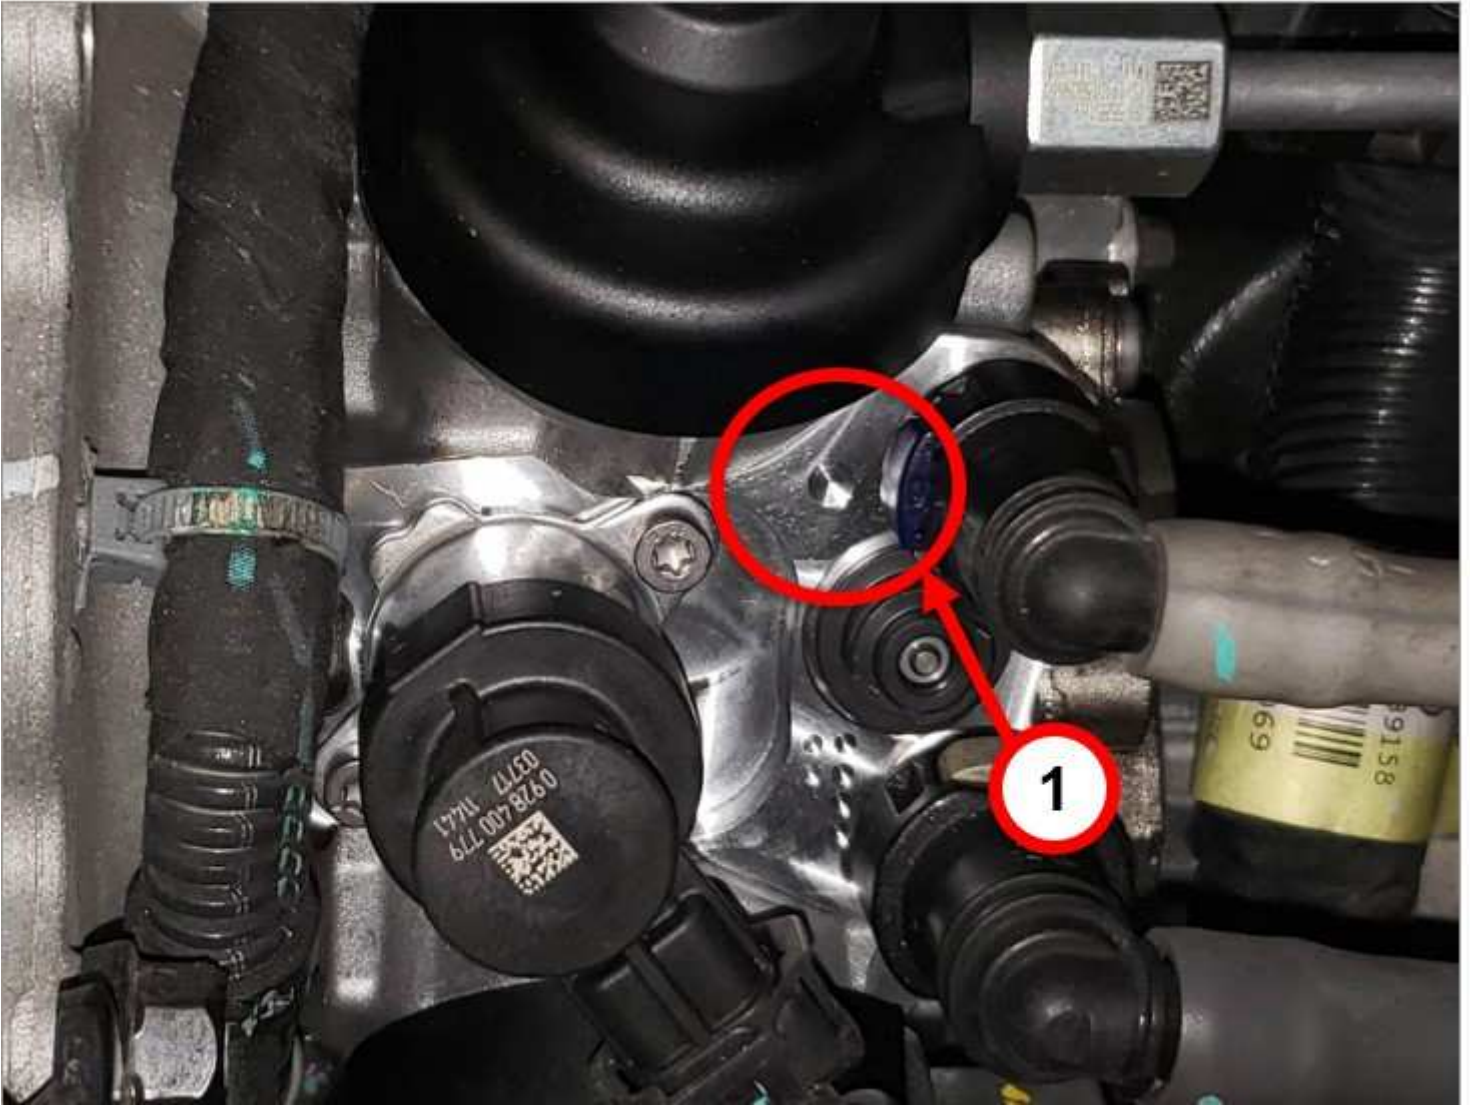
**Fig. 1**  
**New Style Symmetrical Cam Design Pump**

1. Inspect the fuel injection pump to see which pump the vehicle has:
  - Vehicles with the new style Symmetrical Cam design pump will have one large single dot embossed in the pump housing (Fig. 1)
  - For vehicles equipped with a Symmetrical Cam pump, choose the calibration labeled Symmetric Cam, or Sym Cam.

1 - One large Single Dot on Housing
