**NUMBER:** 18-010-21 REV. A

**GROUP:** 18 - Vehicle Performance

Flash: Powertrain Control Module (PCM) Updates

| 2019 | (DJ) | RAM 2500 Pickup |

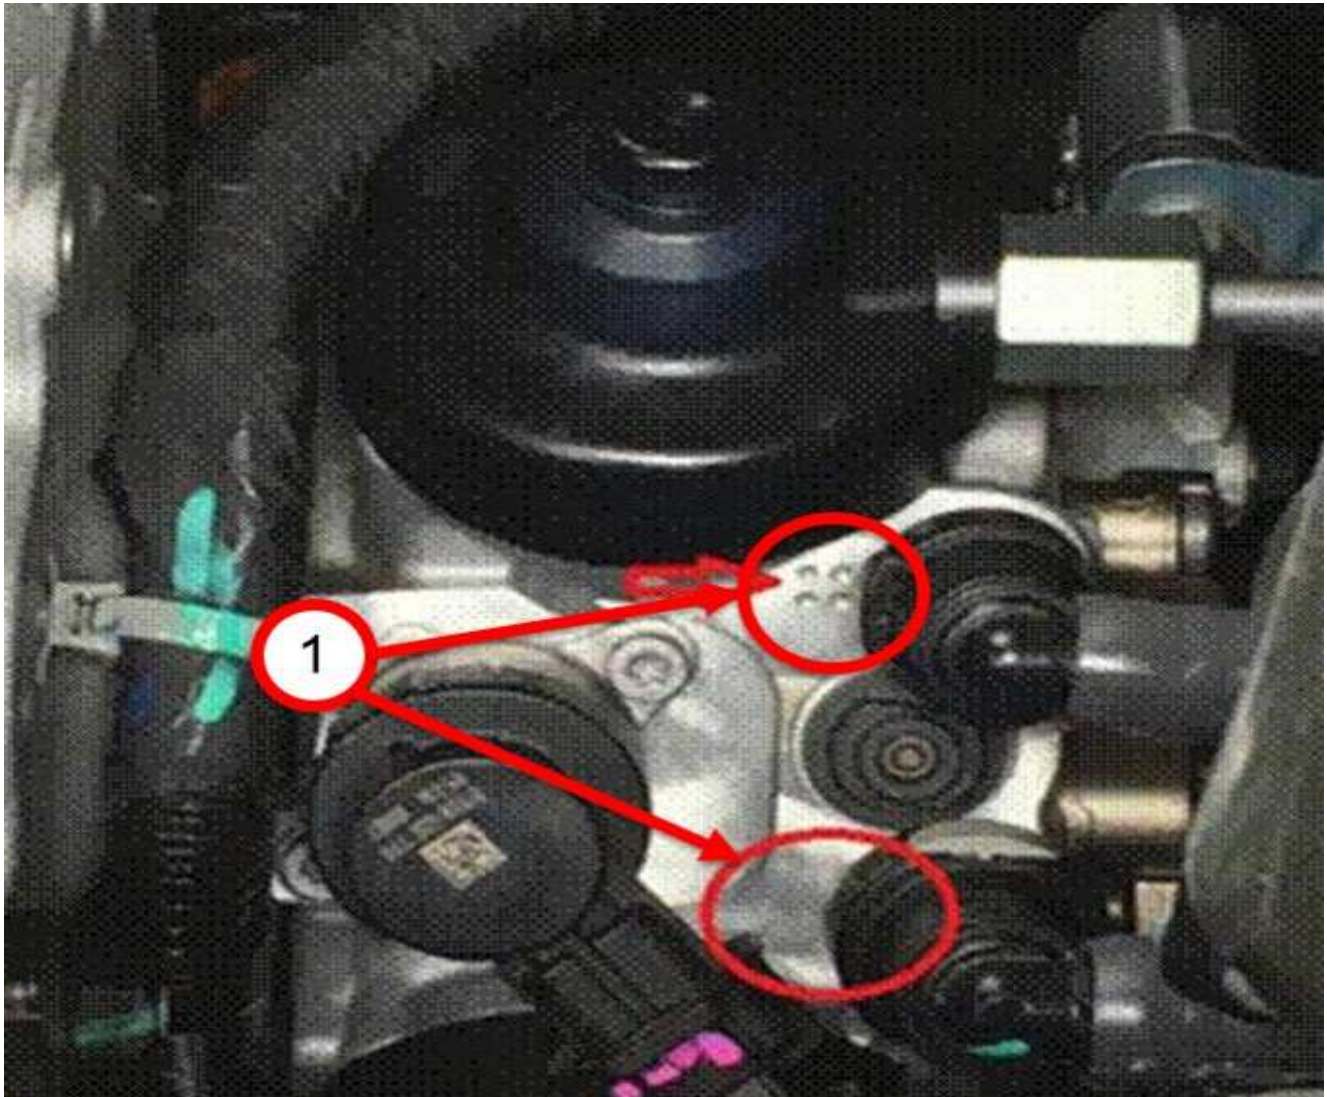
**Fig. 2**  
**Old Style Asymmetrical Cam Design Pump**

- Vehicles with the old style Asymmetrical Cam design will have multiple dots embossed in the pump housing (Fig. 2) .
- For vehicles with an Asymmetrical Cam pump, choose the calibration labeled Asymmetric Cam or Asym Cam.

1 - Multiple Dots on Housing
