**NUMBER:** 18-012-21 REV. A

**DATE:** March 5, 2021

Flash: Powertrain Control Module (PCM) Updates

This bulletin involves reprogramming the Engine Control Module/Powertrain Control Module (ECM/PCM) with the latest available software.

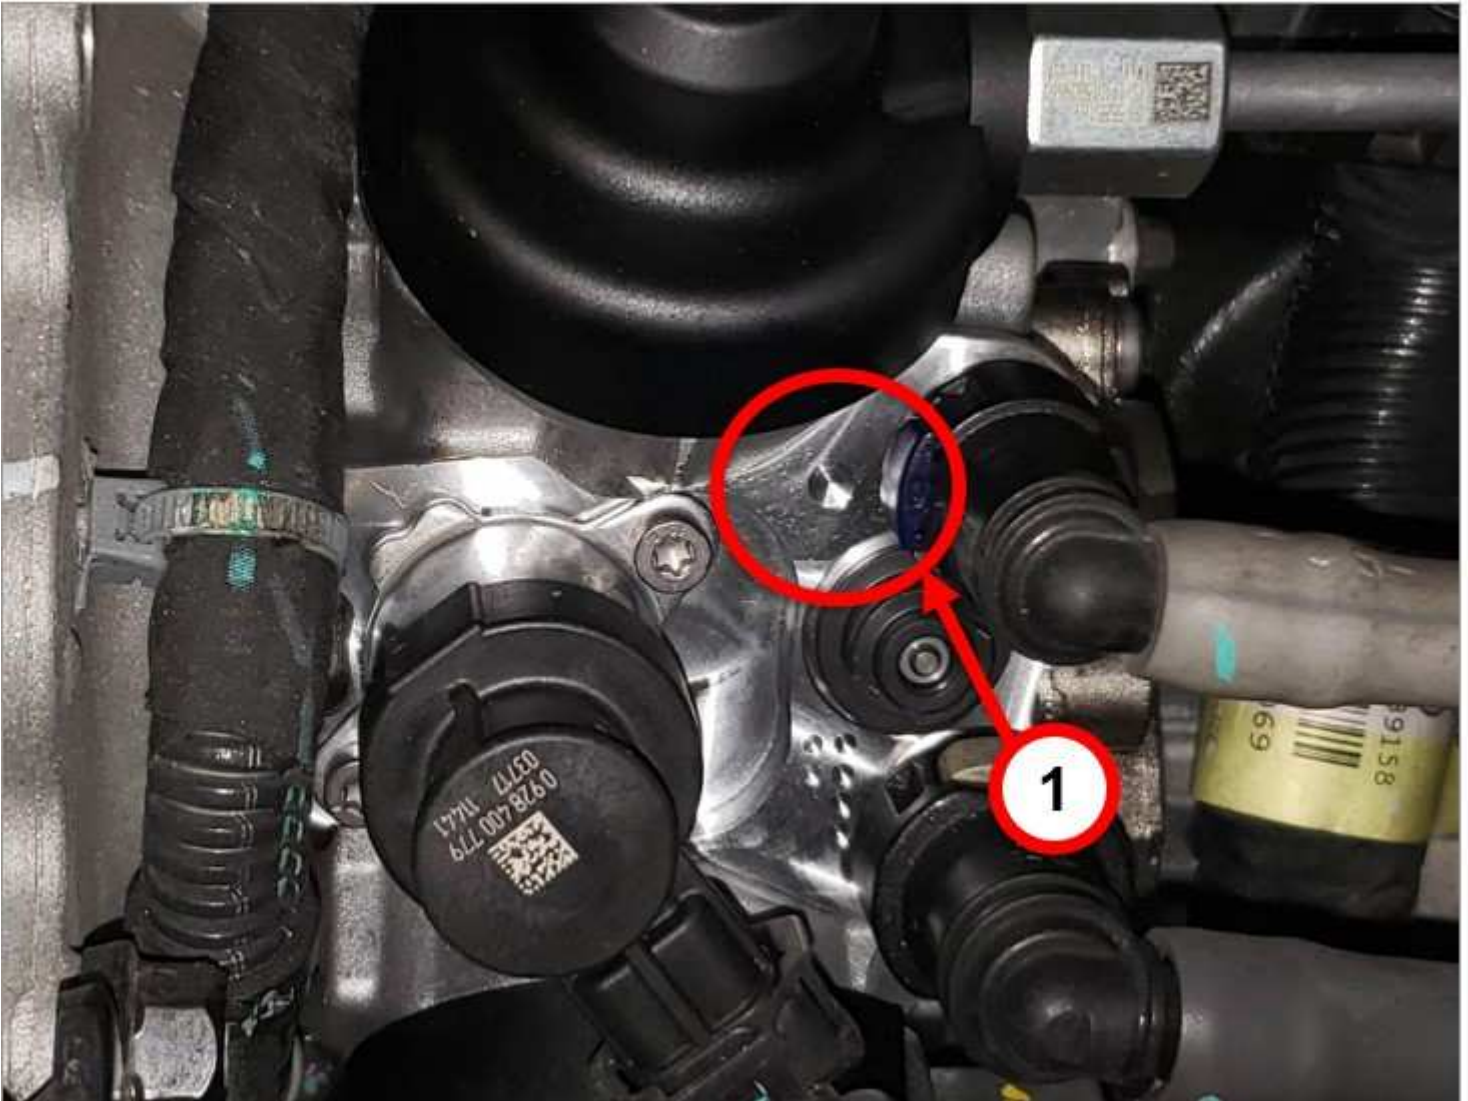
**Fig. 1**  
**New Style Symmetrical Cam Design Pump**

1. Inspect the fuel injection pump to see which pump the vehicle has:
  - Vehicles with the new style Symmetrical Cam design pump will have one large single dot embossed in the pump housing (Fig. 1) .
  - For vehicles equipped with a Symmetrical Cam pump, choose the calibration labeled Symmetric Cam, or Sym Cam.

1 - One large Single Dot on Housing
