**NUMBER:** 09-003-21

**DATE:** March 27, 2021

Transmission Oil Cooler Lines Not Fully Connected

2020 - 2021 (DT) RAM 1500 Pickup

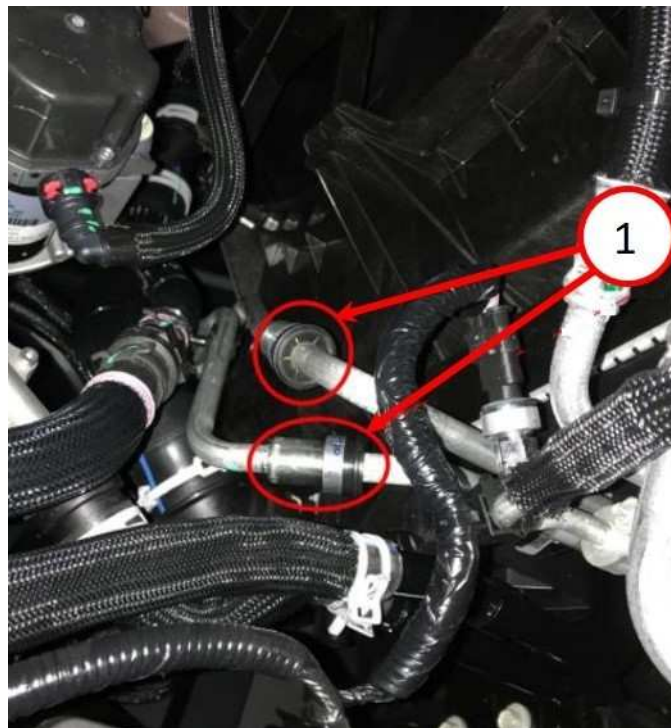
Fig. 1

1. Inspect the TOC lines by pulling on lines to see if they come loose and separate the connection. The black assurance caps (Fig. 1) need to be pulled back to inspect.

Transmission Oil Cooler Line (Shown Connected)
