**NUMBER:** 09-003-21 REV. A

Transmission Oil Cooler Lines Not Fully Connected

This bulletin involves inspecting the Transmission Oil Cooler (TOC) lines and reconnecting if necessary.

**\*\*2021\*\*** (DT) RAM 1500 Pickup

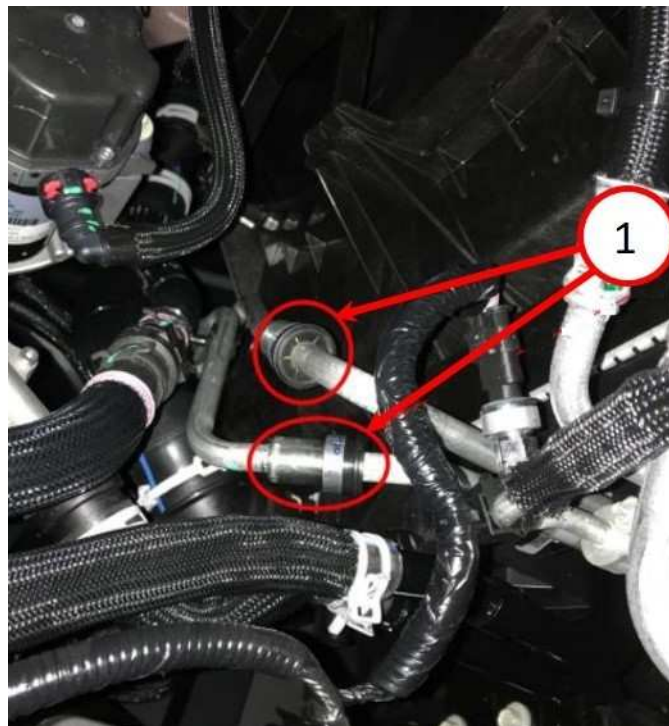
**Fig. 1**  
**Transmission Oil Cooler Line (Shown Connected)**

1. Inspect the TOC lines by pulling on lines to see if they come loose and separate the connection. The black assurance caps (Fig. 1) need to be pulled back to inspect.
