## STAR ONLINE PUBLICATION

**Case Number:** S2108000104

**Symptom/Vehicle Issue:** No Start, On Stop Start Vehicles A MIL Lamp On With DTC P0A97 Combined With The No Start

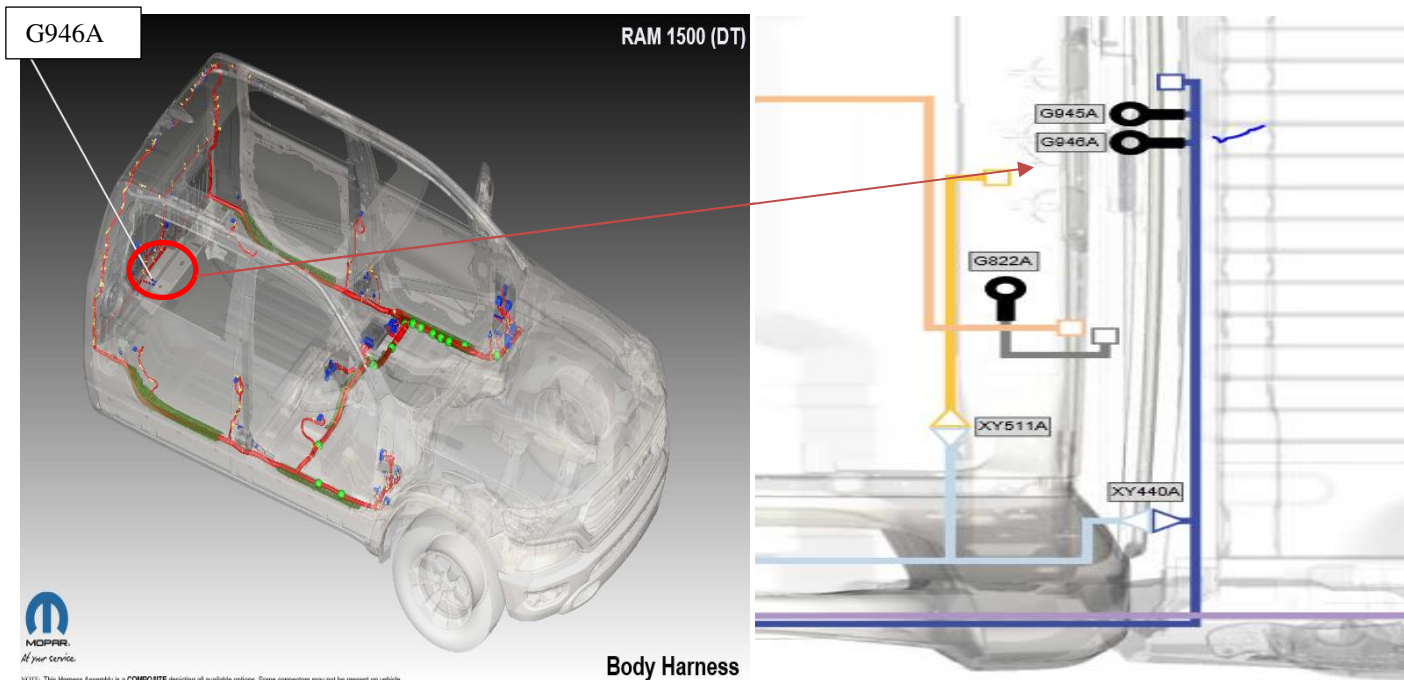
**Customer Complaint/Technician Observation:** Owner complains that the vehicle is not starting. Technician observes RFHUB response issues and on vehicles with BSG (Belt Start Generator) system, no start combined with DTC P0A97-00-HYBRID/EV COOLING FAN 2 PERFORMANCE/STUCK OFF.

**Repair Procedure:** Inspect the G946A ground location, clean and secure the ground location as needed no parts required.
