**NUMBER:** 18-034-21

**GROUP:** 18 - Vehicle Performance

**SUBJECT:**

P203E and P203F Additional Diagnostic Information

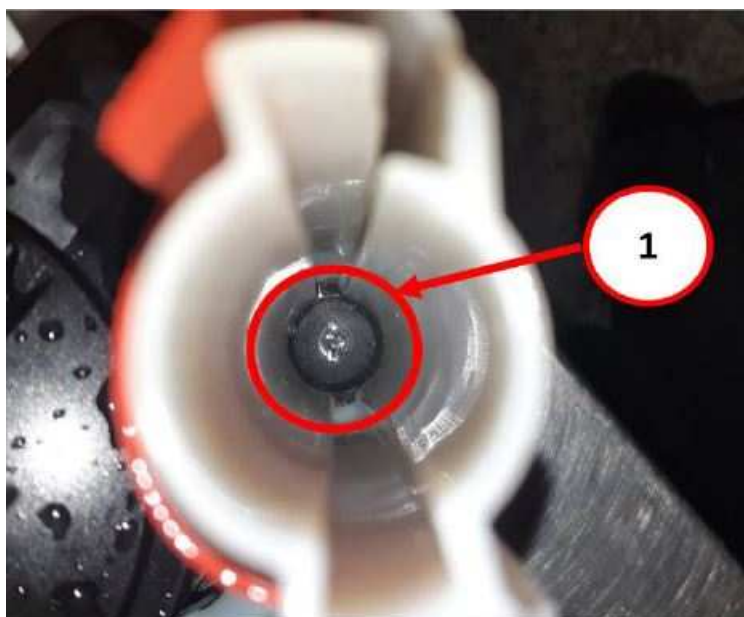
Fig. 1  
DEF Pump Assembly

Another cause of P203E and P203F is residual ice in the DEF tank. Once ambient temperatures reach approximately 12°F (-11°C), the DEF fluid in the tank will freeze. The P203E diagnostic will not run if the DEF tank, and ambient temperatures stay below 39°F (4°C). However, as the ambient temperature warms up, and the tank begins to thaw, the DEF tank may not be completely thawed by the time the P203E DTC enabling criteria are met. If there is a residual layer of ice in the tank, the ice will cause the “no echo” condition setting P203E. Vehicles are especially susceptible to having residual ice in the tank, in areas where there is a large swing in temperatures (from extreme cold to warm), in a short period of time. Additionally, if ice is covering the sensor (Fig. 1) when the temperatures are too cold to run the P203E monitor, it could lead to P203F. Even if there is sufficient fluid level in the tank.

1 - Ice In Level Sensor Focus Tube.

To correct this scenario, the DEF tank must be fully thawed out. Allow the vehicle to sit in a heated shop or garage overnight to thaw. If necessary, remove the DEF pump to drain the fluid, and remove all residual ice. Take care when removing the DEF pump to avoid damage to the pump, and heater mat. Once all the ice has been removed or thawed, follow the **P203E Drive Cycle** below.

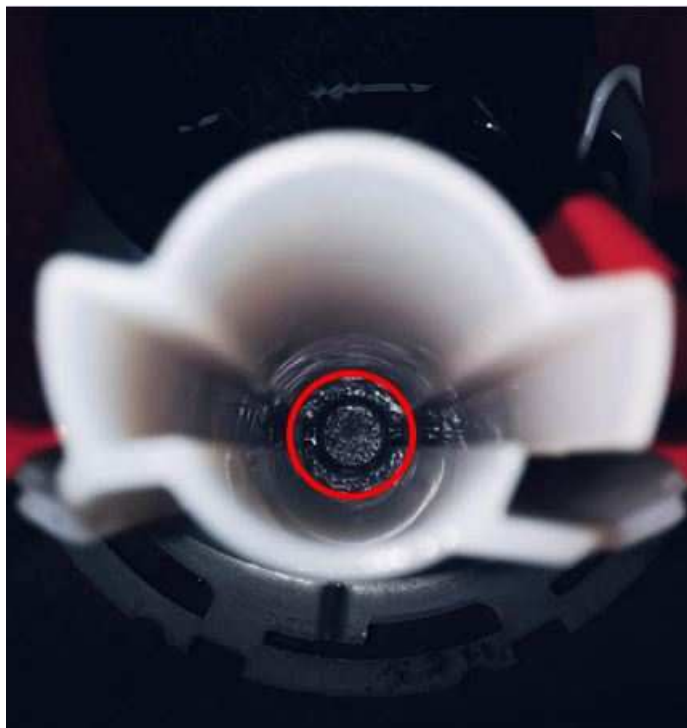
Fig. 2

Another cause of P203E and P203F is the DEF level sensor being covered in a layer or DEF crystals, or ice (Fig. 2) . Vehicles that are in extreme cold for long periods of time can start to have a buildup of DEF crystals on the bottom of the tank. When DEF tanks are completely frozen for long periods of time, evaporation will start to occur. This evaporation of the ice will leave DEF crystallization.

DEF Crystallization Buildup In Level Sensor Focus Tube

Unless the DEF fluid shows signs of contamination, crystallization that has formed in the tank, and on the pump components can be cleaned without having to replace any parts. Flush the tank, and clean the pump components using fresh DEF, or warm distilled water. In some instances, it may be necessary to remove the DEF tank, and agitate the fluid by shaking the tank. Thoroughly drain the DEF or distilled water used to clean the crystallization, and add fresh DEF. If P203E was set, follow the **P203E Drive Cycle** below.
