## STAR ONLINE PUBLICATION

**Case Number:** S2008000132 - Rev. A

**Symptom/Vehicle Issue:** U11E9 Lost Communication With AGS (Active Grille Shutter), Malfunction Indicator Lamp (MIL) Illuminated

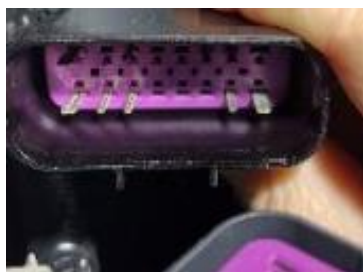
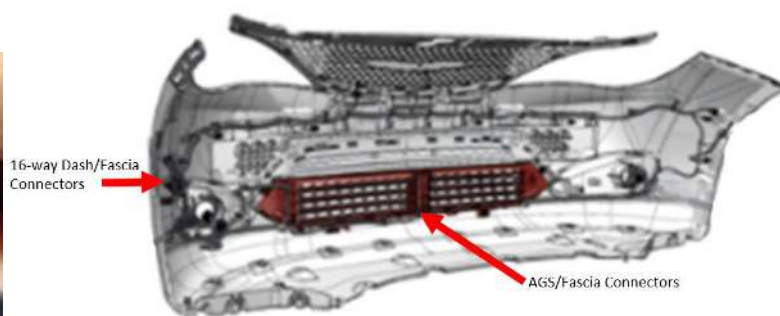
1. Inspect the wiring near the 16-way XY101A Dash to Fascia Connector for nicks and cuts. Also disconnect the connector and inspect for corrosion.

1. If corrosion or damage is present at the XY101A connector. Use connector kit 68497543AA to repair the 16-way dash side connector and replace the fascia side harness. A connector repair kit 68500834AA for the fascia side connector will be available in the future.
2. If corrosion is present in the AGS connector, replace the AGS. Do not add dielectric grease to the AGS/fascia connectors. If corrosion is present in the fascia connector, repair it using connector kit 68396618AB or replace the harness as necessary.
