**NUMBER:** 08-018-21 REV. A

**DATE:** June 19, 2021

Video Routing Module (VRM) Enhancements For Rear Seat Entertainment System

2017 - 2021 (RU) Chrysler Pacifica

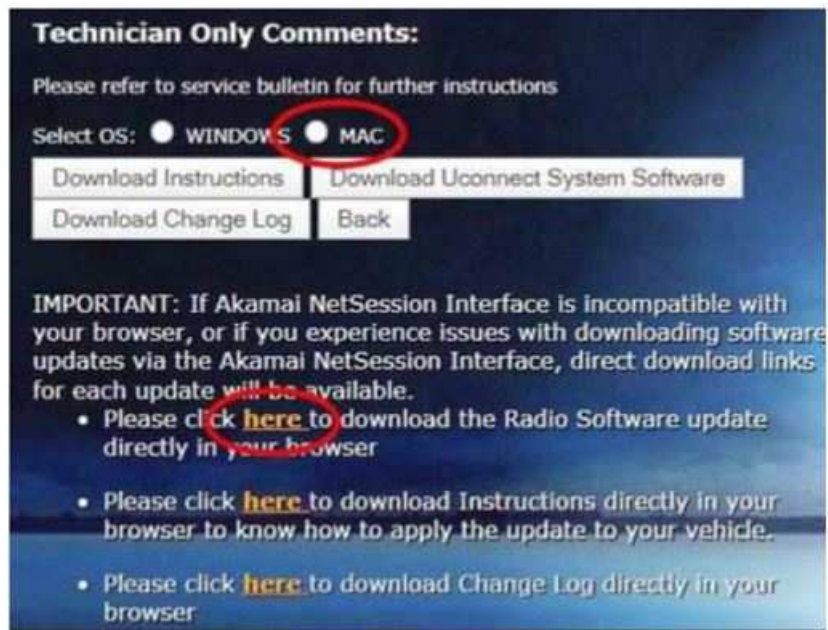
Fig. 1

**MAC Download Steps**

5. Download the software update file to your local PC's desktop. Make sure to select the "MAC" radial button for all downloads (Fig. 1) .

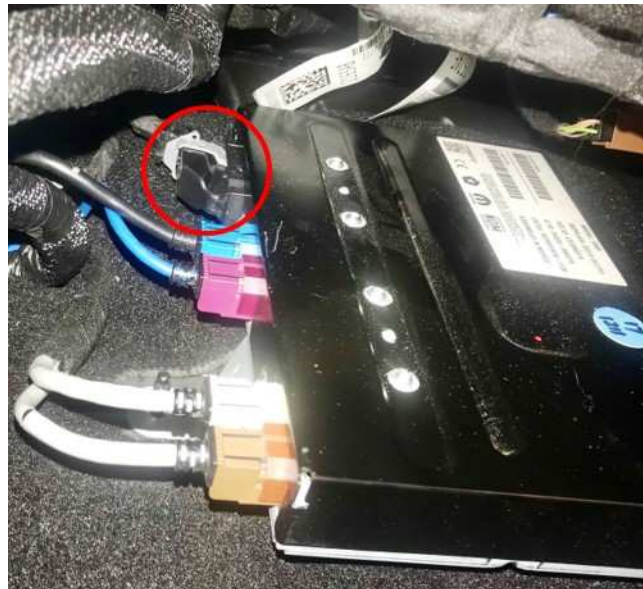
Fig. 2

**VRM Harness Connector**

6. Start the vehicle.
7. With the vehicle still running, disconnect the black and gray VRM harness connector from the VRM found under the front passenger seat (Fig. 2) .

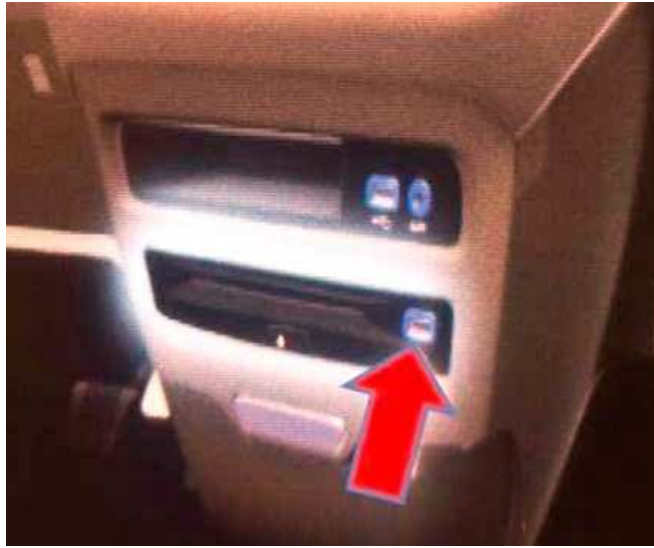
Fig. 3  
Correct USB Port

8. Connect the VRM harness connector to the VRM and verify the system boots.
9. With the ignition on and radio powered up, insert the USB flash drive with new software into the USB port next to the Blu-ray player (Fig. 3) .
