**NUMBER:** 18-010-21 REV. B

Flash: Powertrain Control Module (PCM) Updates

| 2019 | (DJ) | RAM 2500 Pickup |
| 2019 | (D2) | RAM 3500 Pickup |

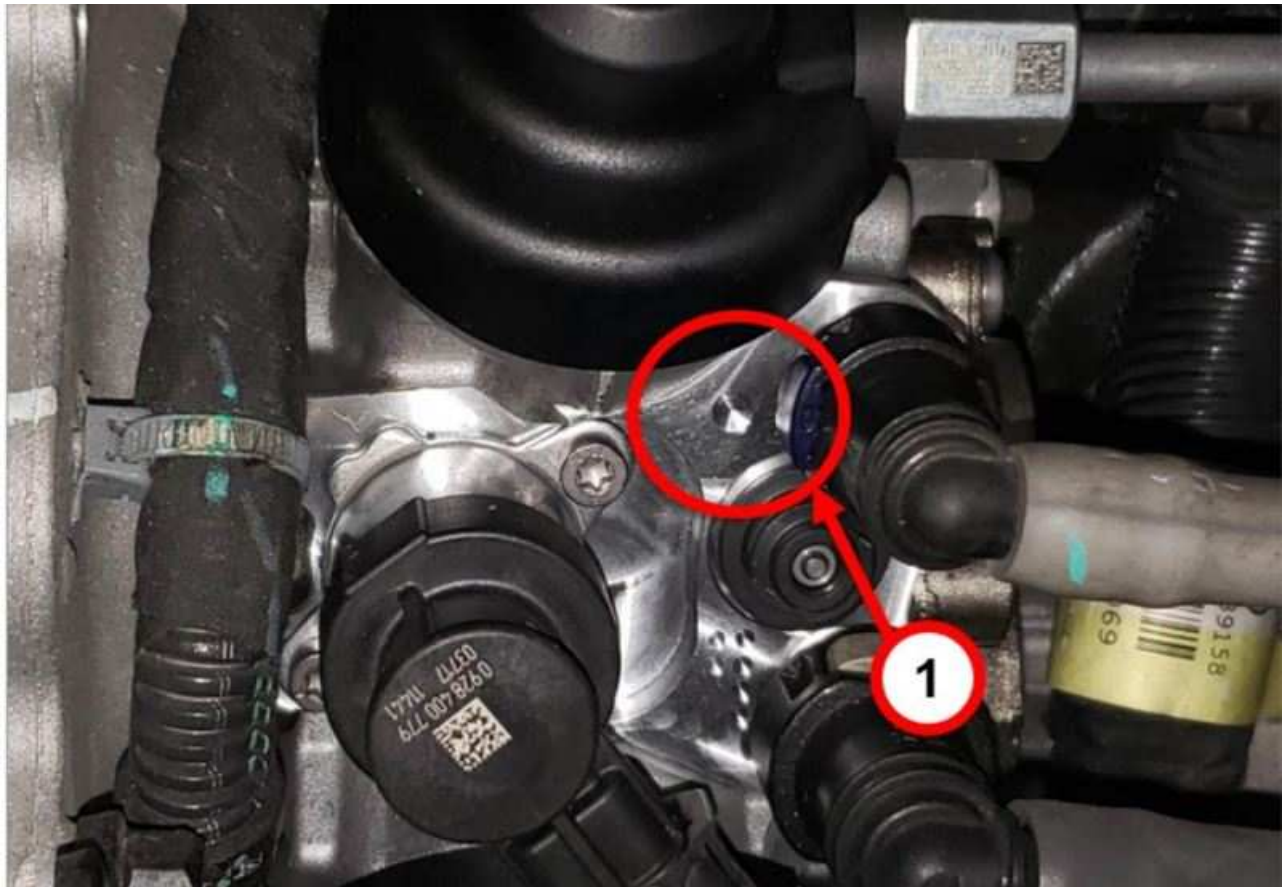
Fig. 1  
New Style Symmetrical Cam Design Pump

1. Inspect the fuel injection pump to see which pump the vehicle has:
  - Vehicles with the new style Symmetrical Cam design pump will have one large single dot embossed in the pump housing (Fig. 1) .
  - For vehicles equipped with a Symmetrical Cam pump, choose the calibration labeled Symmetric Cam, or Sym Cam.

1 - One large Single Dot on Housing
