**NUMBER:** 18-012-21 REV B

**DATE:** June 26, 2021

Flash: Powertrain Control Module (PCM) Updates

| 2020 | (DJ) | RAM 2500 Pickup |

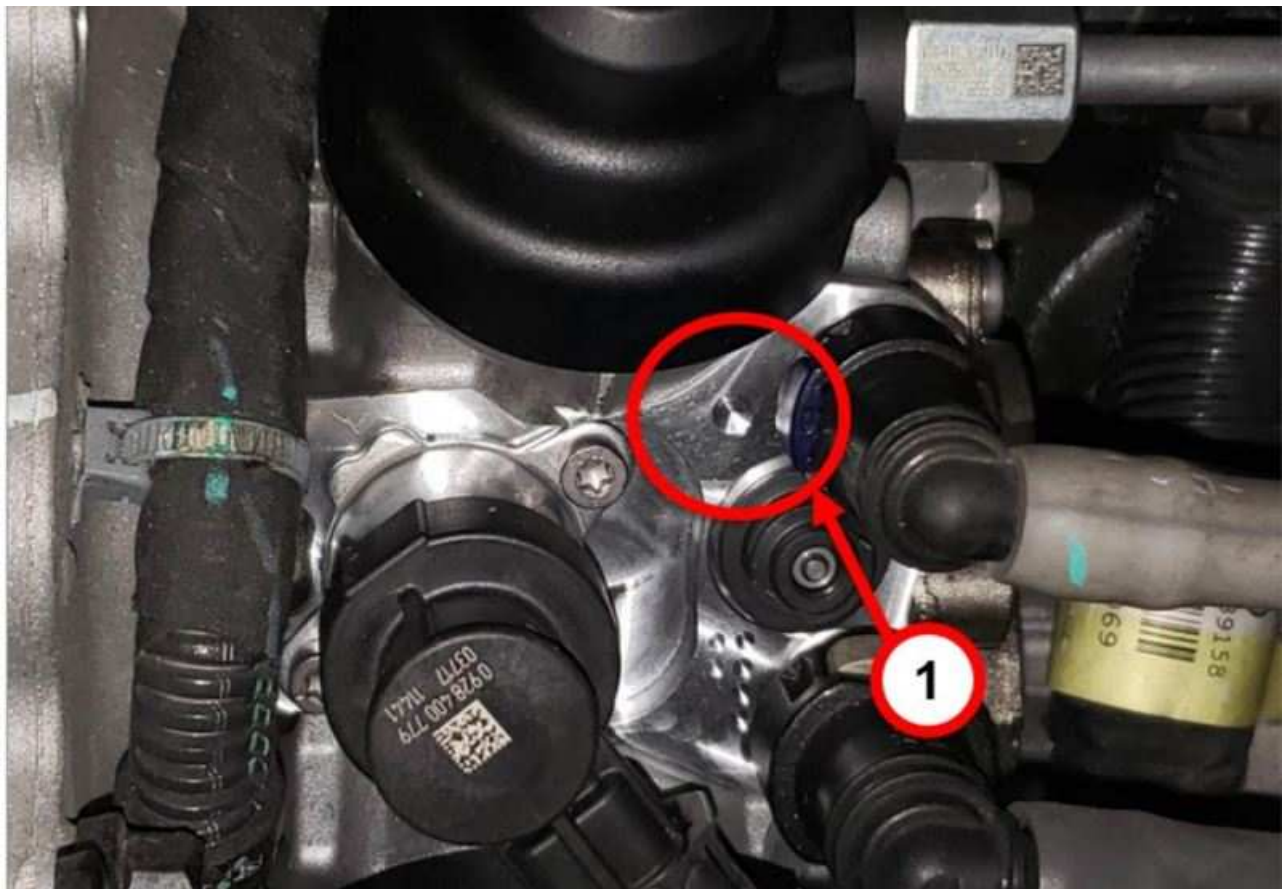
Fig. 1  
New Style Symmetrical Cam Design Pump

1. Inspect the fuel injection pump to see which pump the vehicle has:
  - Vehicles with the new style Symmetrical Cam design pump will have one large single dot embossed in the pump housing (Fig. 1) .
  - For vehicles equipped with a Symmetrical Cam pump, choose the calibration labeled Symmetric Cam, or Sym Cam.

1 - One large Single Dot on Housing
