## STAR ONLINE PUBLICATION

**Case Number:** S2008000128

**Symptom/Vehicle Issue:** Hood Ajar Lamp On, ESS Inoperative, DTC P257E Engine Hood Switch Circuit Low

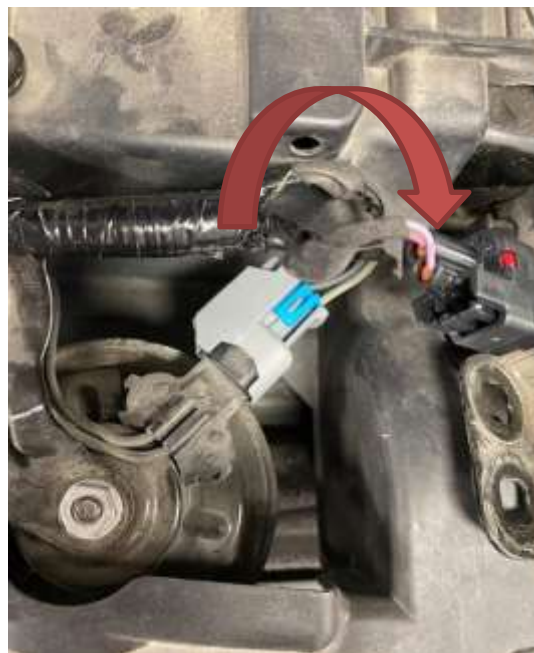
**Customer Complaint/ Technician Observation:** Owners complains after a recent vehicle service the hood ajar warning lamp is illuminated and the ESS (Electric Start Stop) system does not operate. Technician observed the vehicle is setting DTC, P257E-Engine Hood Switch Circuit Low

**Discussion:** Test the operation of the horn, if the horn does not function inspect the hood ajar connector and horn connector located at the latch assembly near the horn/hood latch. The two component connectors are similar in size and may be reversed during repairs. Re-connect the appropriate connector to the horn and ajar switch; test the operation to complete.
