# Technical Service Bulletin

27 48V Vehicle electrical system warning, DTC P0CA700 and/or U046900 stored in the starter/generator control module/ECM

27 22 45 2058831/5 September 27, 2022. Supersedes Technical Service Bulletin Group 27 number 22-41 dated March 2, 2022, for reasons listed below.

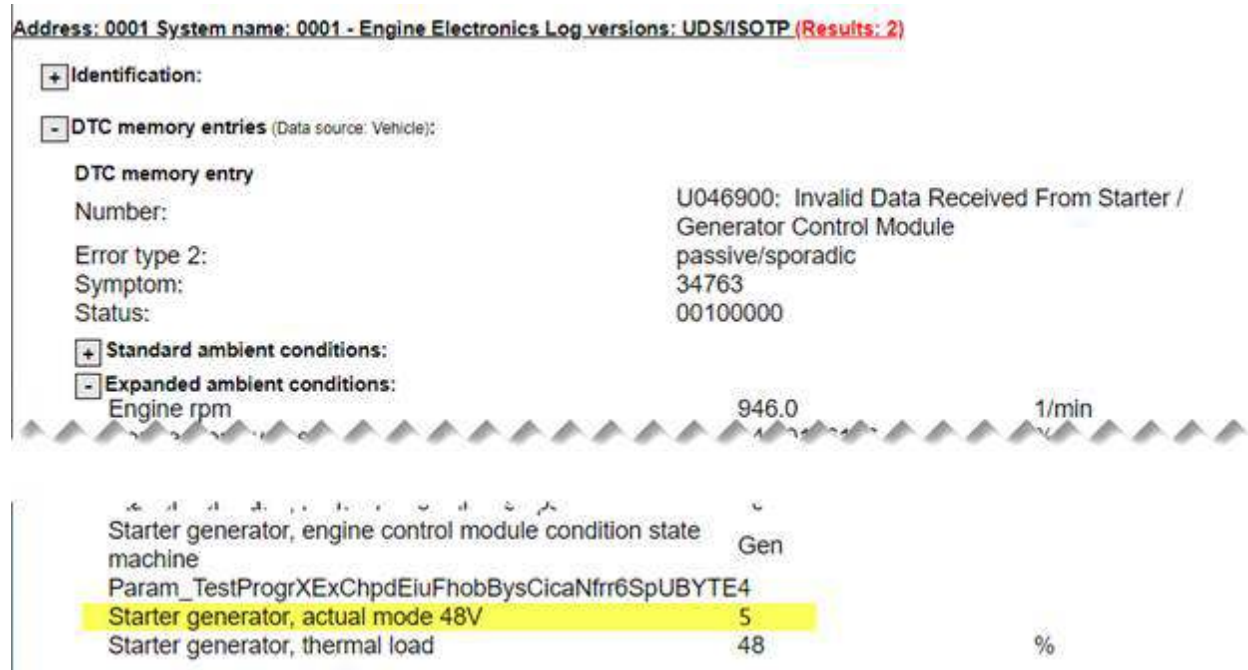
*Figure 1. DTC U046900 with Expanded ambient condition "Starter generator, actual mode 48V" value of 5 in the engine control module (ECM), J623 (address word 0001).*

1. If DTC U046900 is found in the ECM, J623 (address word 0001), check the expanded ambient conditions of this DTC for the value of "Starter generator, actual mode 48V".
2. If the expanded ambient conditions value for "Starter generator, actual mode 48V" is 5 (Figure 1) for DTC U046900, then replace the starter generator. If no value is displayed, please submit an ODIS feedback.
