# Technical Service Bulletin

96 "Audi Active Lane Assist/Traffic Jam Assist: malfunction!", DTC U112300 is stored in one of two control modules 96 22 79 2061932/5 September 28, 2022. Supersedes Technical Service Bulletin Group 96 number 22-78 dated September 16, 2022, for reasons listed below.

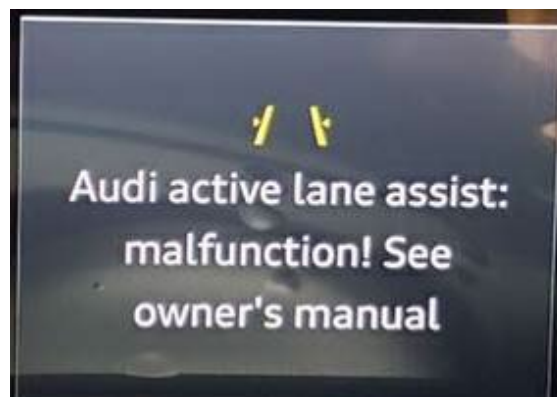
- "Audi Active Lane Assist: malfunction!" (Figure 1).

*Figure 1. Example of a message.*

The two DTCs U112300 mentioned in the condition point to a malfunction of the capacitive steering.

1. Inspect the steering wheel for exterior or mechanical damage, for instance, deep scratches.
2. If mechanical damage is found, this is due to external influence and may not be covered under warranty.
3. Remove the airbag from the steering wheel.

4. Make sure that all wiring visible on the steering wheel is in good condition and that all connectors are properly secured.
5. If obvious damage is not found upon completing steps 1 through 3, then replace the steering wheel.
