## TECHNICAL SERVICE BULLETIN

### Level 3 Charging - Illuminated Charger Service Required Indicator In The IPC And/Or Multiple DTCs

**22-2355**

19 September  
2022

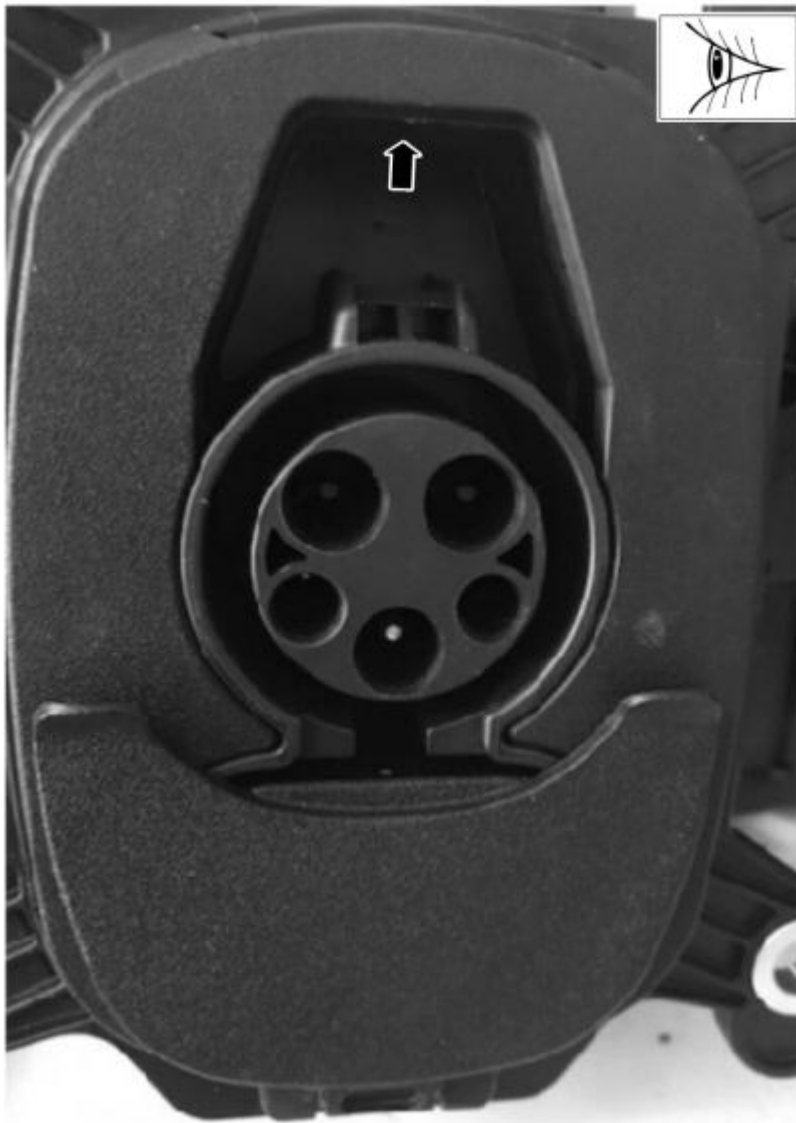
Figure 2

1. Inspect the charge port lock actuator pin. (Figure 2) Is the charge port lock actuator pin missing or loose?

- (1). Yes - proceed to Step 2.
  - (2). No - this article does not apply. Refer to Workshop Manual (WSM), Section 414-03B High Voltage Battery Charging System.
2. De-energize the high voltage system. Refer to WSM, Section 414-03A High Voltage Battery > Mounting and Cable > General Procedures.
3. Gain access to the charging port.
- (1). For e-Transit vehicles, remove the front bumper cover. Refer to WSM, Section 501-19 Front Bumper Cover > Bumpers > Disassembly and Assembly.
    - Remove the retainers and the charge port cover. (Figure 3)
