# Service Bulletin

Bulletin No.: 22-NA-089

**Subject:** Intermittent Click Noise at Front of Vehicle, ABS, Traction Control System (TCS)/  
Stabilitrak Lamps May Illuminate Intermittently and/or Deactivate for Ignition Cycle -  
DTC P215B, C0035-C0051 Set

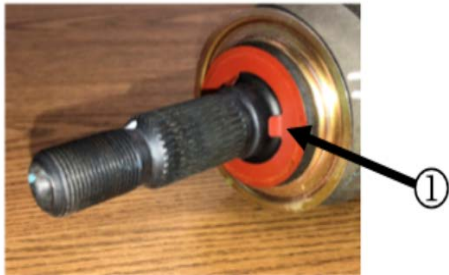
| Cause | <div style="text-align: center;"> <br/> </div> <p style="text-align: right;">5317523</p> <p>This condition may be caused by fracturing of the front wheel drive shaft anti-click washer (1) and possible collateral damage to the ABS wheel speed sensor (WSS).</p> | | |

| Correction | <p>Note: In cases where the condition is verified on both sides of the vehicle, replace the anti-click washer on BOTH sides.</p> <p>Upon verifying the condition, replace the anti-click washer with new part number shown below on the affected half shaft(s), then inspect the wheel speed sensor on that side(s).</p> <p>Note: If DTC P215B ever sets on the vehicle, replace the wheel speed sensor.</p> | | |

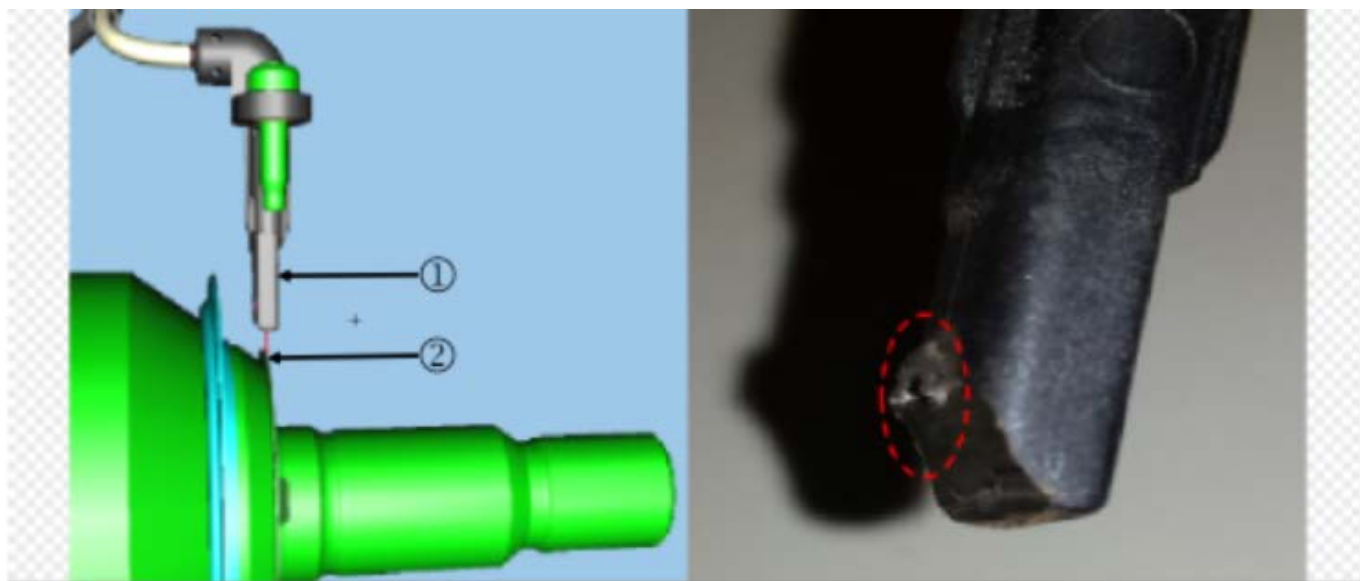
5317529

Note: The example above depicts the wheel speed sensor (WSS) (1) directly in-line with the anti-click washer (2) on the outboard joint of the half shaft.

4. Inspect the WSS on either/both affected side(s) for possible damage.
  - " If no damage is found, reinstall the lower control to the steering knuckle, and no further repairs are necessary.
  - " If the WSS is found to be damaged (as shown circled in the graphic above), continue ahead to step # 5.
