# TECHNICAL SERVICE BULLETIN

EC20-031B

NTB21-001B

## TCM COMMUNICATION ERROR CAUSING A NO START CONDITION

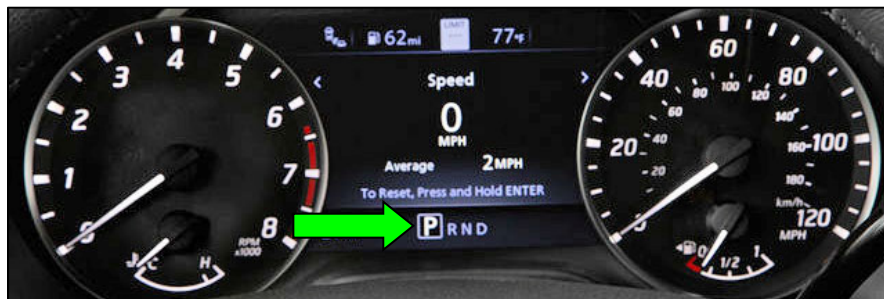
Figure 1

**NOTE:** If the Park indicator is not displayed in the Driver Information Center (Figure 1) and C-III plus does not display the current TCM part number after a 2 minute wait with the ignition ON, engine OFF, this TSB **does not apply**. Refer to the ESM for further diagnostic information.
