# TECHNICAL SERVICE BULLETIN

NTB21-002A

## TCM COMMUNICATION ERROR CAUSING A NO START CONDITION

**APPLIED VEHICLES:** 2020 Frontier (D40)  
**APPLIED TRANSMISSION:** 9 Speed A/T (GE9R01A)

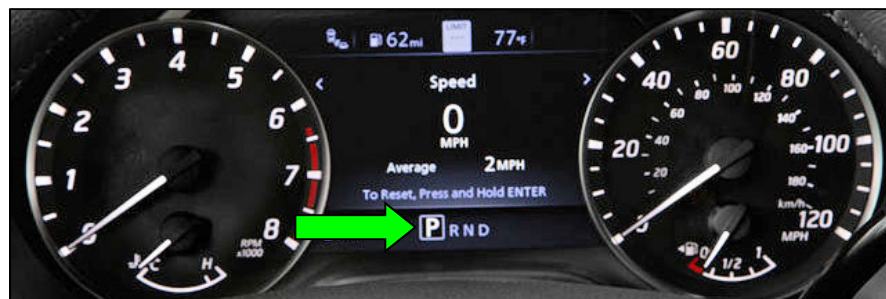
Figure 1

**NOTE:** If the Park indicator is not displayed in the Driver Information Center (Figure 1) and C-III plus does not display the current TCM part number after a 2 minute wait with the ignition ON, engine OFF, this TSB **does not apply**. Refer to the ESM for further diagnostic information.
