## STAR ONLINE PUBLICATION

**Case Number:** S2008000033 REV. A

**Symptom/Vehicle Issue:** MIL Lamp On, DTC P0325 - Knock Sensor 1 Circuit

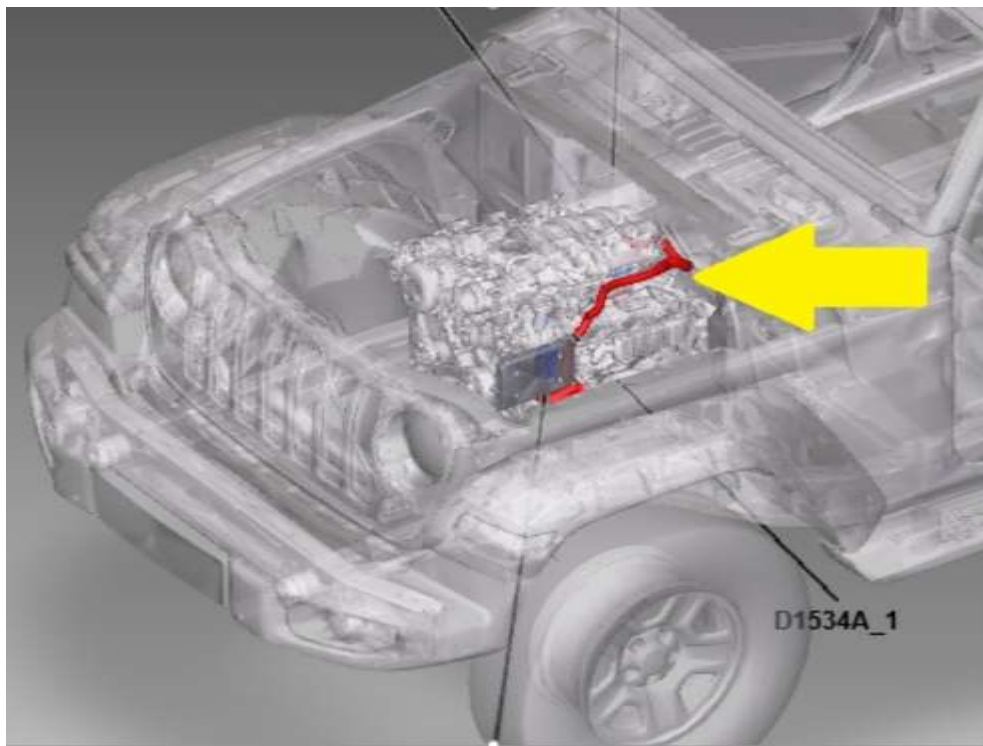
Fig 1

**Discussion:** Inspect the engine harness routing at the rear of the engine as shown and or the C2 PCM connector terminal 53 K42 circuit Fig 1, 2, 3. Review for any signs of chaffing damage, repair and isolate the harness concern as needed, no parts required.

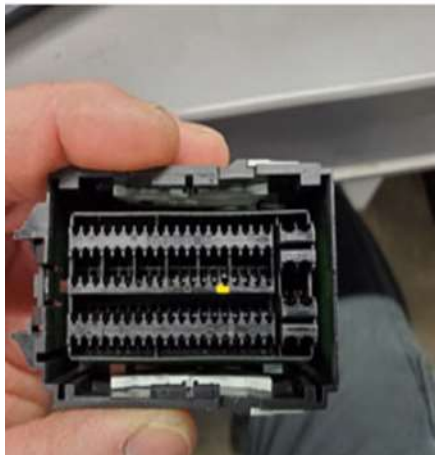
Found the terminal for K42 Knock Sensor 1 Signal pushed out of the PCM C2 Connector

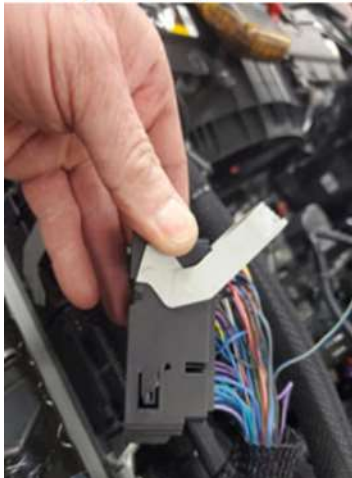
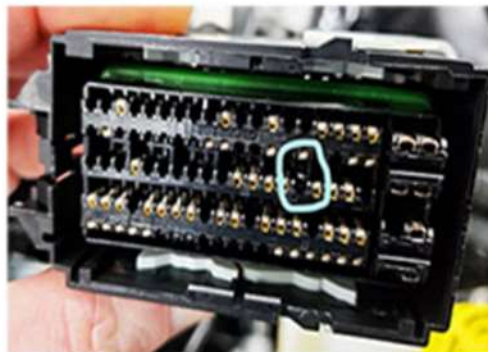
Fig 3

Plastic locking tab in the PCM C2 Connector that retains/locks pin in place is deformed and allows the pin to push out

Terminal Pushout at Cavity #53
