## STAR ONLINE PUBLICATION

**Case Number:** S2223000004

**Symptom/Vehicle Issue:** Cruise Control SET + Button Sticking. DTC P1593 SPEED CONTROL SWITCH 1/2-STUCK and or P0585 SPEED CONTROL SWITCH 1/2 CORRELATION

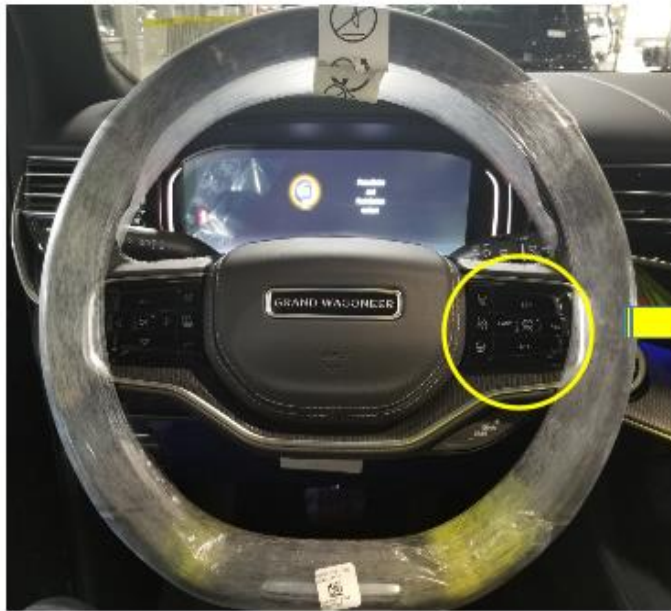
"SET+" Switch

**Customer Complaint/Technician Observation:** Customer may complain the “SET + button does not return to its rest position or it sticks down. If this condition is present inspect the steering switch bezel fitment. The bezel may be not fully seated and sticking up causing the condition. See the below figures for more information.

To allow the "SET+" switch to spring back to design position, press down on the trim piece at the top right corner of the switch. You will hear a "click" noise when the trim piece becomes fully engaged.

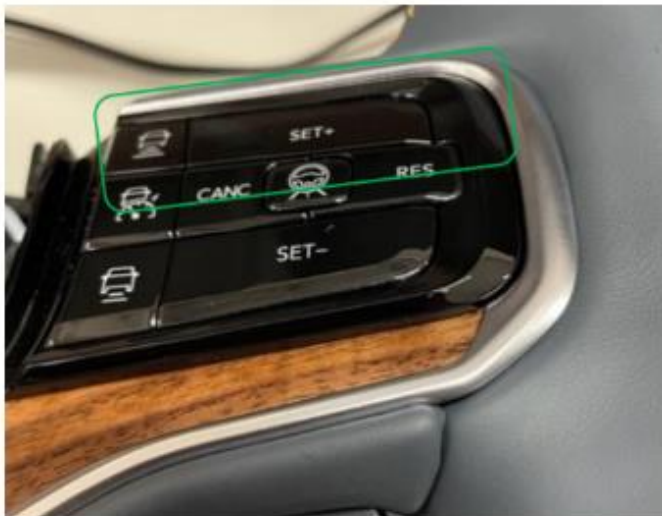
### ACCEPTABLE SWITCH

"SET +" Switch is flush with surrounding trim piece by design.

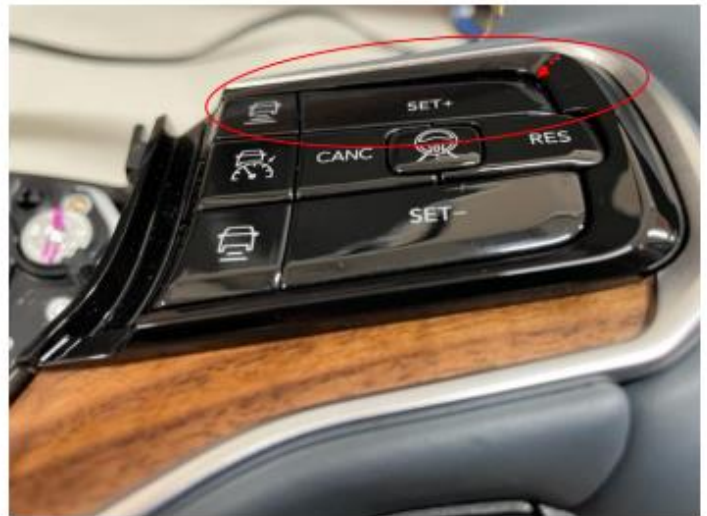
### UNACCEPTABLE SWITCH

"SET +" Switch is stuck and under flush with surrounding trim piece.
