## STAR ONLINE PUBLICATION

**Case Number:** S2118000007

**Symptom/Vehicle Issue:** MIL Lamp On DTC P1CEA BOOST SIDE EVAP PURGE SYSTEM PERFORMANCE

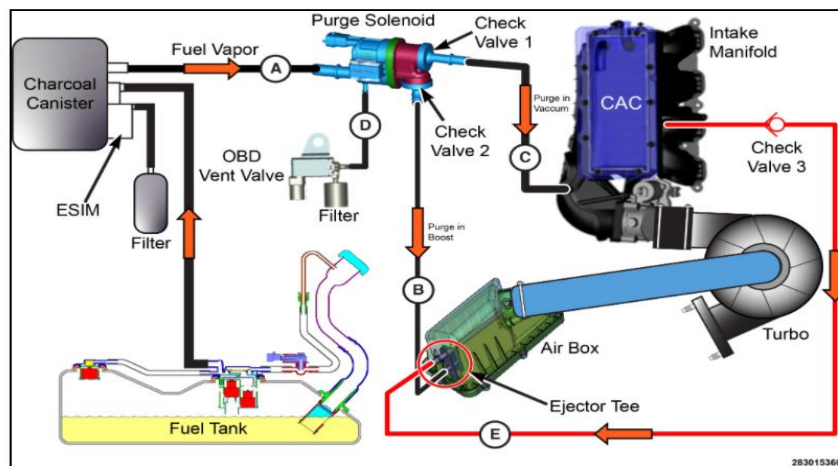
Figure 1  
EVAP System for 2.0L engines.

**Repair Procedure:** See figure 1 and figure 2 for proper connection of the lines. Before proceeding on disconnecting the vacuum line for the Ejector Tee (the line that connects to the Purge Solenoid at the outer end), check to determine if the lines are properly connected to the Purge Solenoid port and the CAC/Intake Manifold port.

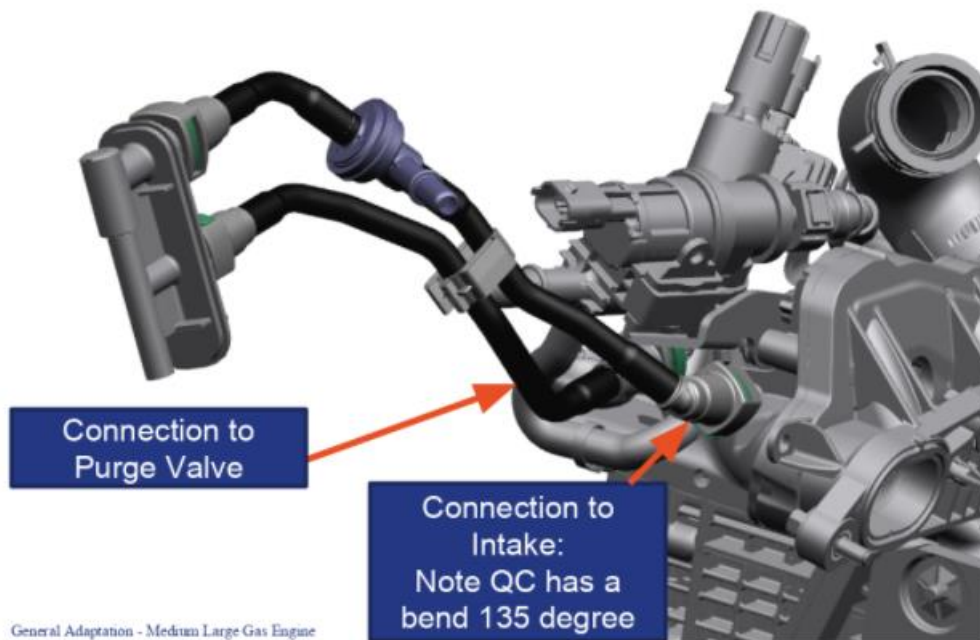
Figure 2  
Lines connected to Air Box Ejector Tees and Purge Valve Port and CAC/Intake Manifold Port.
