**NUMBER:** 09-009-20

Improperly Installed Exhaust Gas Recirculation (EGR) Valve

2018 - 2019 (DS) RAM 1500 Pickup

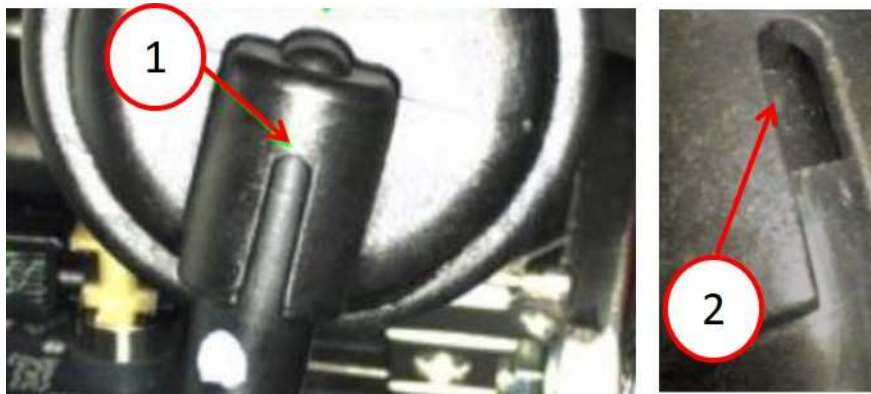
**Fig. 2**  
**No Gap And Gap Shown On**

3. Inspect the vacuum tube is fully seated in the vacuum actuator and there is no gap present (Fig. 2) .

- 1 - Vacuum Tube Fully Seated (No Gap Present) In The Vacuum Actuator
  - 2 - Vacuum Tube Not Fully Seated (Gap Is Present) In The Vacuum Actuator
-

**NOTE:** To ensure the vacuum hose is fully seated on the vacuum actuator, a soapy water solution may be used to facilitate fully seating the vacuum hose on the vacuum actuator. Ensure components are dry afterwards if soapy water is used.

4. Is the vacuum tube fully seated in the vacuum actuator (Fig. 3) ?
- YES >>> Proceed to [Step 5](#) of the Diagnostic Procedure.
  - NO >>> Fully seat the vacuum tube on the vacuum actuator. Proceed to [Step 5](#) of the Diagnostic Procedure.

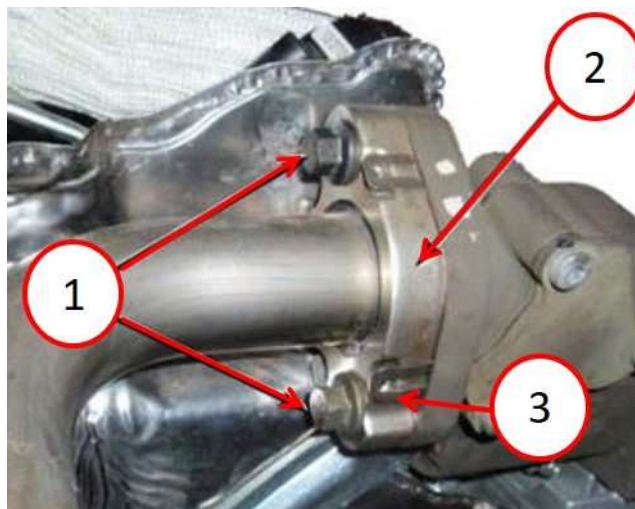
Fig. 4

5. Inspect both the upper and lower EGR tube gaskets (inlet – from turbo/outlet – to intake) that are mated to the EGR valve and that all gasket tabs showing on the **exterior of the tube flange** (Fig. 4) .
- Also inspect that all upper and lower EGR tube flange bolts are tight (Fig. 4) .

- 1 - Lower Tube Flange Bolts
- 2 - Lower Tube Flange
- 3 - Gasket Tabs Shown Properly Installed On Exterior Of Flange

6. Is the either upper or lower EGR tube gasket damaged, missing, gasket flange tabs not showing or the flange bolts loose?
    - YES >>> Proceed to [Step 1](#) of the Repair Procedure.
    - NO >>> Proceed to [Step 7](#) of the Diagnostic Procedure.
  7. Re-torque all the tube flange bolts to 25 N·m (18 ft. lbs.).
  8. Install the fuel injector silencer and engine cover. Refer to the detailed service procedures available in DealerCONNECT/Service Library under: 09 - Engine, 3.0L Turbo Diesel/Cover, Engine/Installation.
- This bulletin has been completed, use inspection LOP (25-01-43-90) to close the active RRT.

**NOTE: If the EGR tube flange bolts appear tight, it is recommended all flange bolts be re-torqued.**

3. Clean surface and install the upper EGR intake air tube using a new tube to EGR gasket, with gasket tabs bent over on the exterior of the flange ([Fig. 4](#)) . Refer to the detailed service procedures available in DealerCONNECT/Service Library under: Service Info>25 - Emissions Control/Exhaust Gas Recirculation, Diesel/Tube, Exhaust Gas Recirculation (EGR)/Installation.

7. Remove the two bolts holding the lower EGR tube to the EGR valve.
8. Carefully pull the lower EGR tube away from EGR valve and discard the gasket.
9. Clean surface and install the lower EGR tube using a new tube to EGR gasket, with gasket tabs bent over on the exterior of the flange (Fig. 4) .
10. Install the EGR tube bolts and tighten the bolts to 25 N·m (18 ft. lbs.).
11. Install the fuel injector silencer (Fig. 6) .
12. Install the intake air tube. Refer to the detailed service procedures available in DealerCONNECT/Service Library under: Service Info>09 - Engine, 3.0L Turbo Diesel/Air Intake System/Tube, Intake Air/Installation.
13. Install the engine cover. Refer to the detailed service procedures available in DealerCONNECT/Service Library under: 09 - Engine, 3.0L Turbo Diesel/Cover, Engine/Installation.
14. Using the wiTECH 2, clear all DTCs that may have been set.
