## STAR ONLINE PUBLICATION

**Case Number:** S1923000047 Rev A

**Symptom/Vehicle Issue:** P1D73 AGS (Active Grille Shutter Performance),  
Malfunction Indicator Lamp (MIL) Illuminated

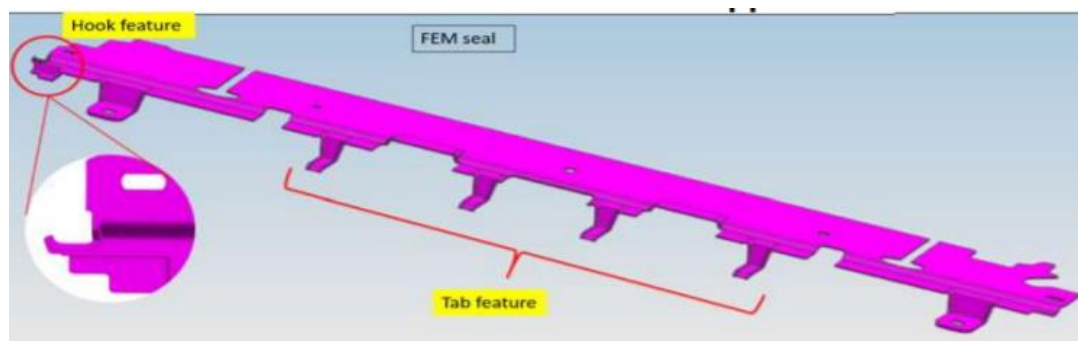
- Front End Module (FEM) seal is causing the Active Grille Shutter (AGS) to bind on gas and diesel vehicles.
- Powertrain Control Module (PCM) software is creating potential false setting of P1D73 code due to a software issue on gas vehicles.

Fig 2. FEM seal attached to mid core support area

1. If the vehicle is built prior to 3/13/19. Replace the Front End Module (FEM) seal with part number 68359231AC or later. See fig. 2. The new FEM mid seal has wire harness clips at the ends and 4 tabs to improve fit and attachment.
