## STAR ONLINE PUBLICATION

**Case Number:** S2008000131 - Rev. B

**Symptom/Vehicle Issue:** U11E9 Lost Communication With AGS (Active Grille Shutter), Malfunction Indicator Lamp (MIL) Illuminated

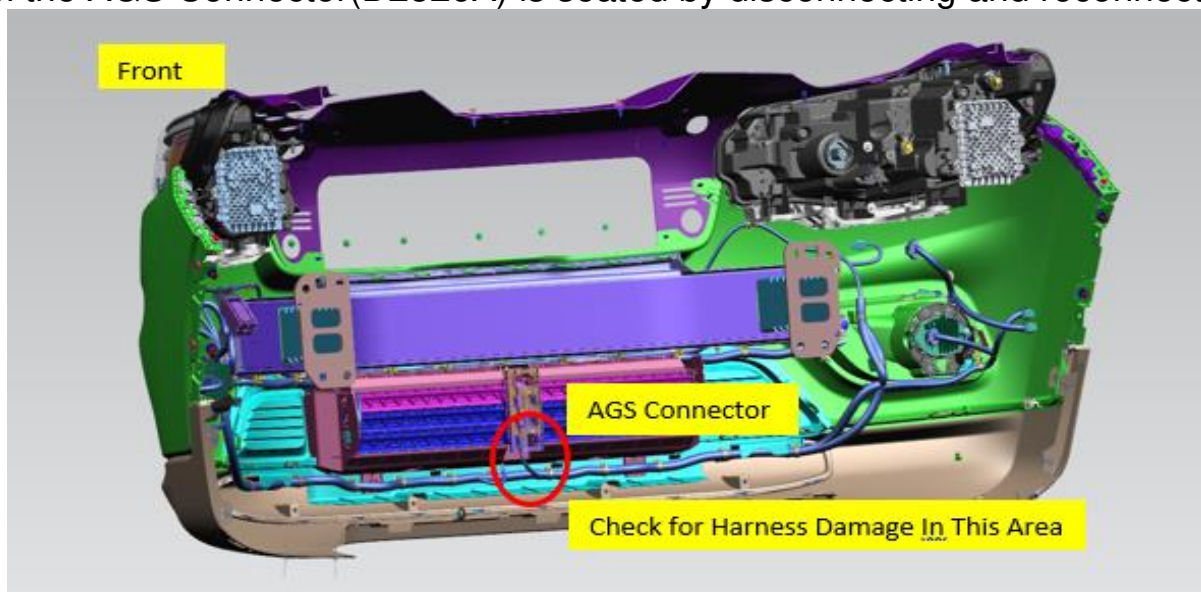
**Diagnosis:** Scan the vehicle for DTC's. If DTC U11E9 – Lost Communication with AGS is active or stored a wiring concern likely exist. Before replacing the AGS, inspect the wiring harness for signs of damage. Small cuts or nicks in the wiring harness have been found by engineering. Including circuits A940B, D511A, Z985BB. You should also confirm the AGS Connector(D2826A) is seated by disconnecting and reconnecting it.

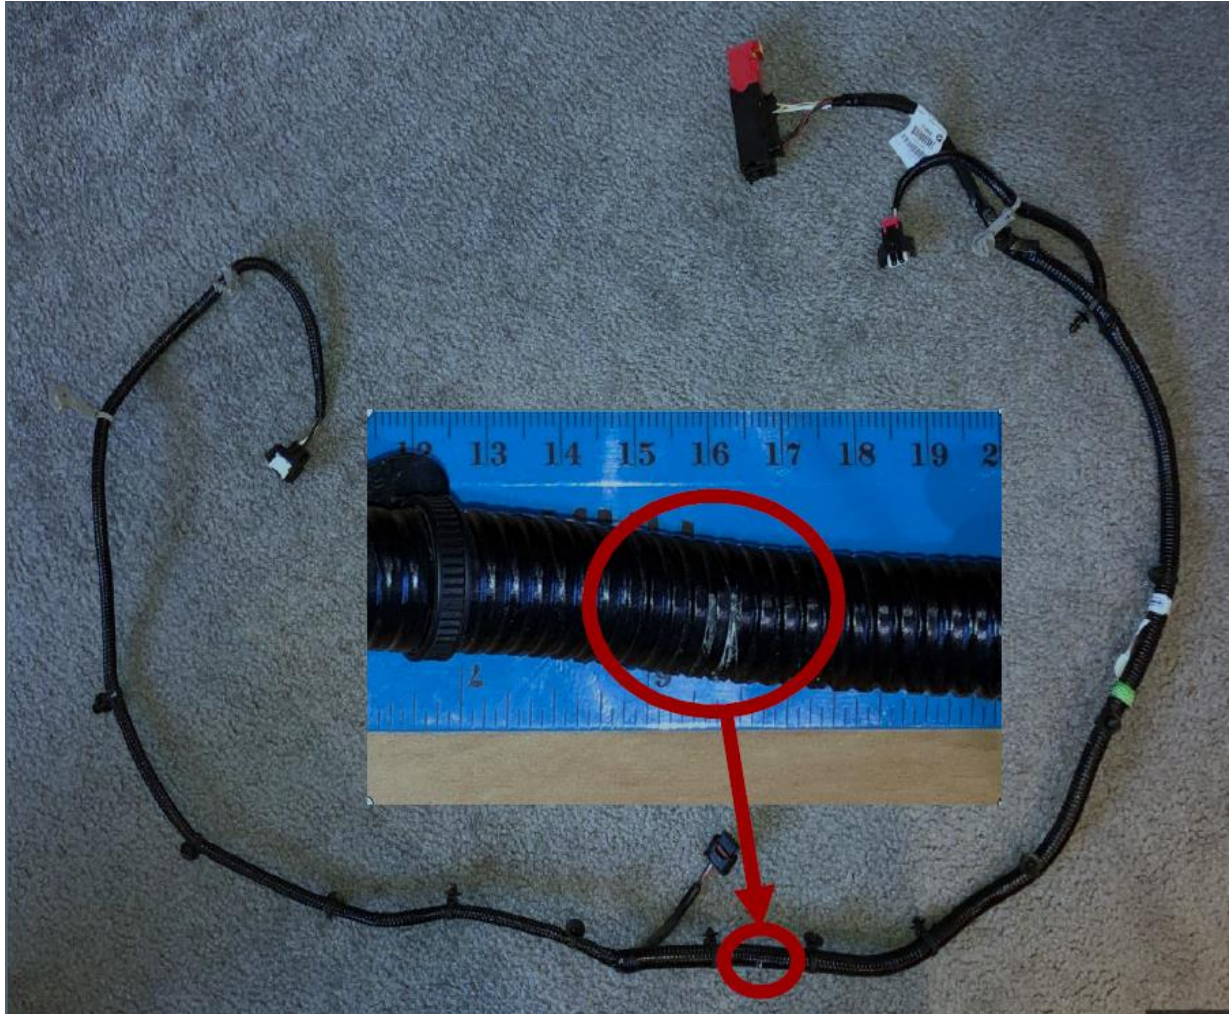
**Discussion:** Damaged fascia wiring harnesses are causing a loss of communication with fully functioning Active Grill Shutter(AGS) units.

**Damaged AGS Wiring Harness**

**Repair:** Use wiring kit 68396618AB to repair the fascia wiring harness or replace the harness if standard repair methods cannot be applied.

It is also advised to inspect the AGS connector for corrosion. If corrosion is present inside the AGS connector, the AGS connector and AGS will need to be replaced.
